Structural Engineers Inspection

Agricultural Barn
Red House Farm
Main Street
Brothertoft
PE20 3SW

| PCC Document Management | |
|---|---|
| Job Number: | 10397 |
| Date of Issue: | February 2021 |

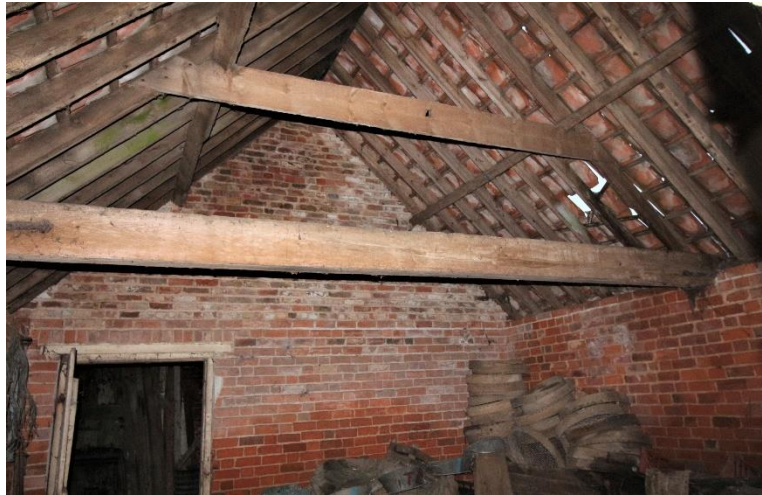
The pitched roof construction to the enclosed store area is formed in rafters,

with collars providing lateral support to the wall plates and preventing roof spread. As with all timber roof structures on traditional barn buildings, it will be necessary to undertake repairs to the roof

members as these are usually affected to some degree by rot and wood boring beetle infestation. The roof should be stripped of the existing covering of pantiles and battens. The wall plates rafters and purlins and ties should be checked for evidence of rot or infestation. Any areas where rot or infestation has caused a loss of structural capacity will require splicing, or in extreme cases, replacement. All timbers should be treated to give long term resistance to rot and infestation.

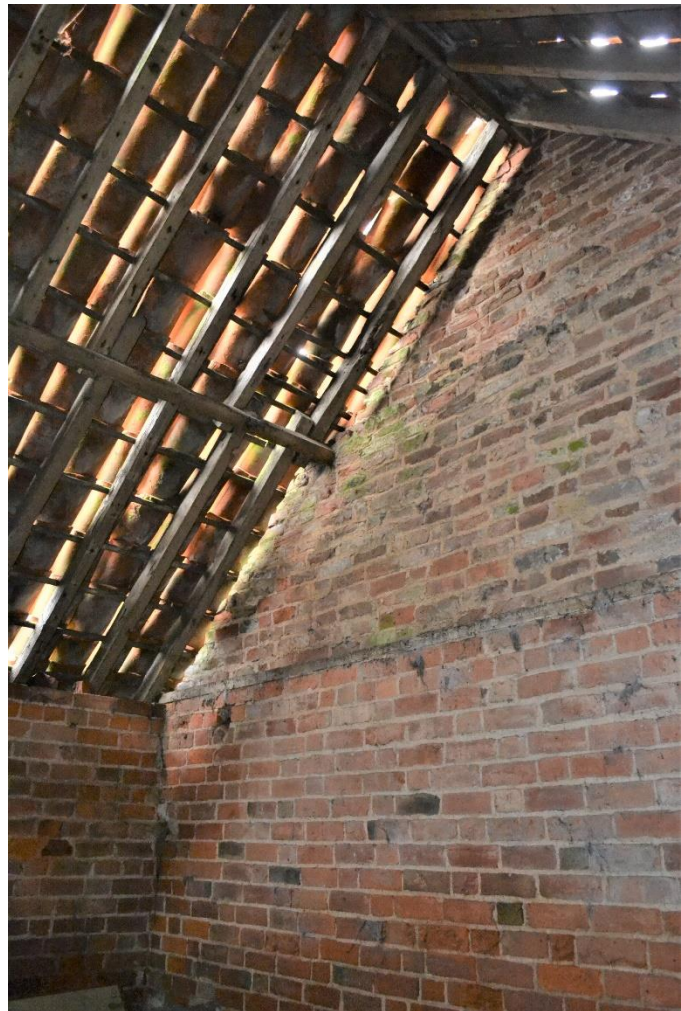
Subject to the repairs outlined above, the roof structure appears to be sufficiently robust to

support allowances for snow loading and dead loads including existing pantiles and to support new loading required for the conversion. This includes new dead loads including standard services, insulation, and new internal finishes. It is

observed that the stability and robustness of the roof has been proved as the roof has been in place for 130 years.

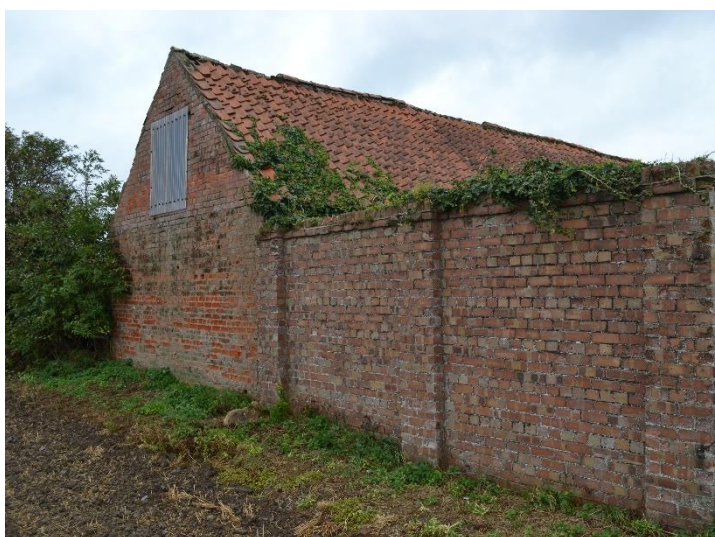
In general, the brickwork appears to be in good condition, showing no obvious evidence of any significant structural movement, although some minor fracturing has occurred and there is some relatively minor misalignment of the southern gable wall. These minor fractures

may be repaired by the repointing work that is necessary due to weathering of the masonry. Some bricks have eroded more significantly and should be replaced. This is normal on a barn of this age where the occasional brick is more porous and less resistant to saturation and frost damage. The good condition of the brickwork is exemplified by the

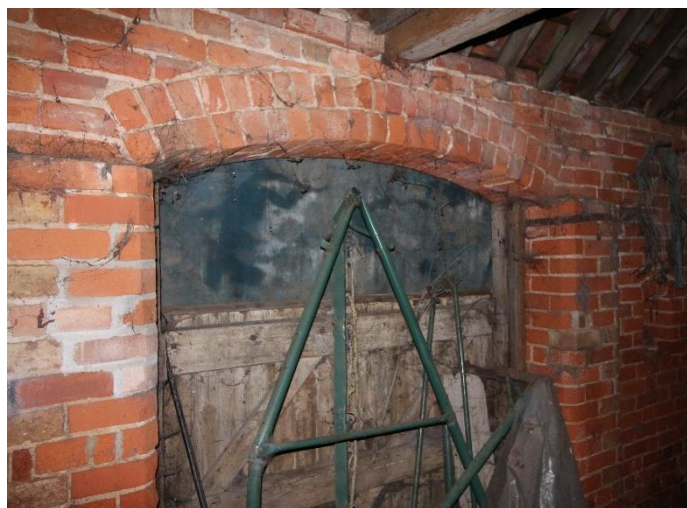
The good condition of the brickwork is exemplified by the

internal view of the south facing arched door opening included within the text. There is no “springing” of the arch and the chamfered bricks forming the piers either side of the door show a high standard of construction.

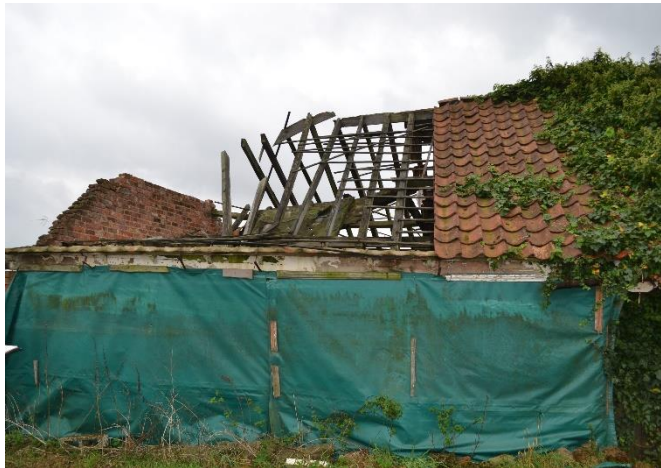
Repair to the northern gable wall will be required where this was damaged when the cart shed roof collapsed. It is observed that the collapse was due to the poor condition of the roof as a result of rot and infestation of the timbers and through no failure of the walls or foundations

of the original building. We include within the text a photograph of the building prior to the failure of the roof. The projecting buttresses that formed the northern wing of the U-shaped barn should be re-modelled as piers to provide a stable and robust form to the northern end of the east wall.

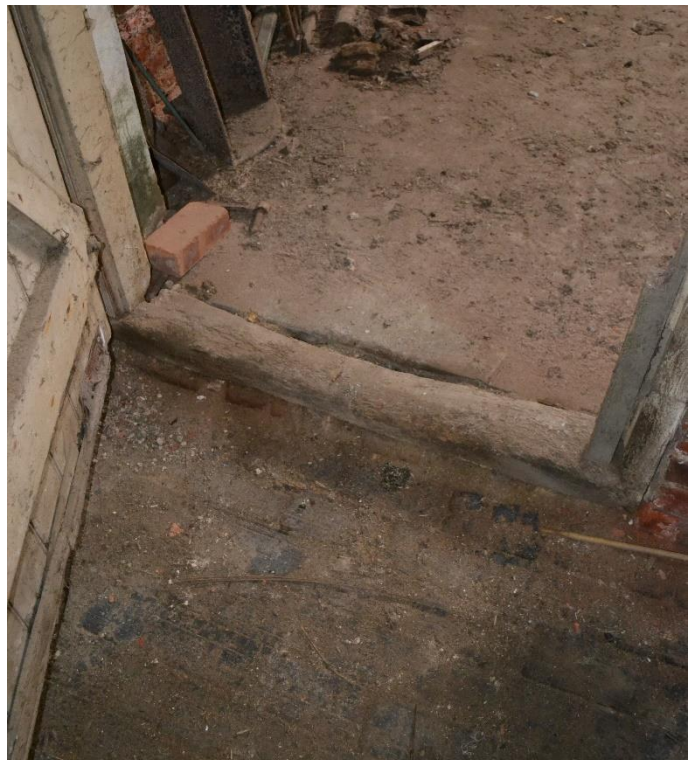
The existing floor may either be broken out and re-constructed or left in place as I understand that it will be necessary to raise the floor level due to flood risk considerations. If the floor is raised it may be advisable to raise the external level to prevent retaining wall loading to the brick elevations. The existing floor will act as a suitable base to support a new floor including insulation, hardcore fill and a concrete slab.
