FLOOR TIMBER ROT
INVESTIGATION REPORT
&
REPAIR METHOD STATEMENT

SHODFRIARS HALL

SOUTH STREET
BOSTON, LINCOLNSHIRE

April 2023

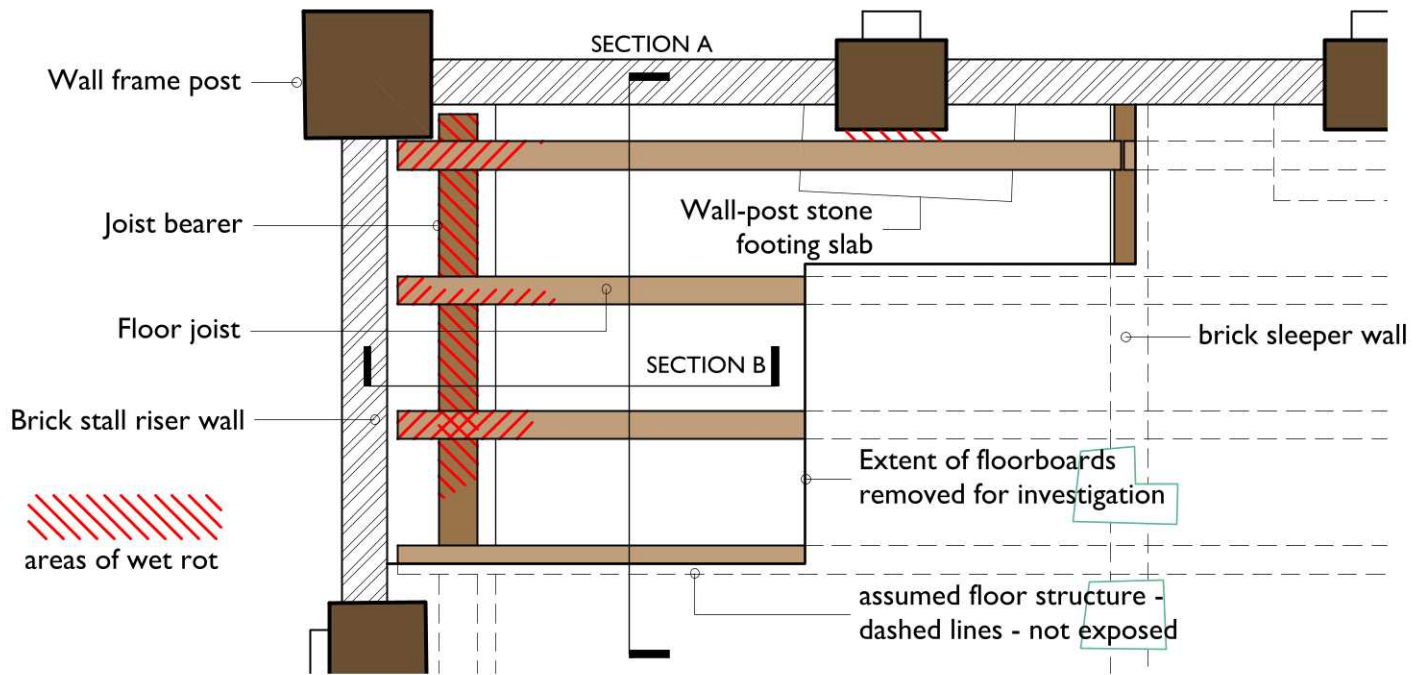
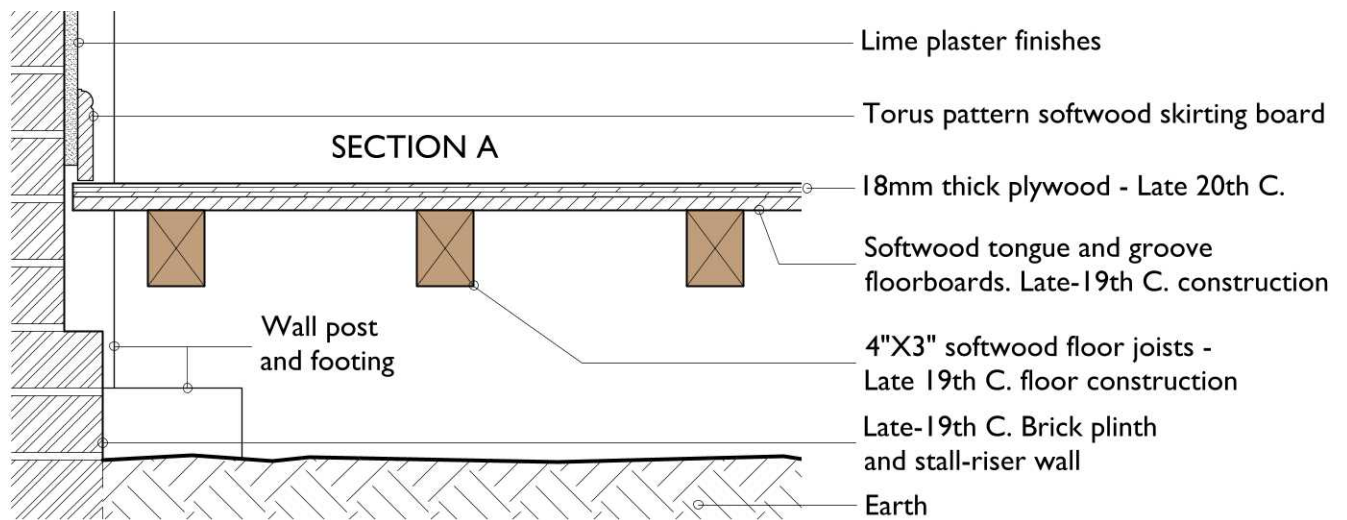
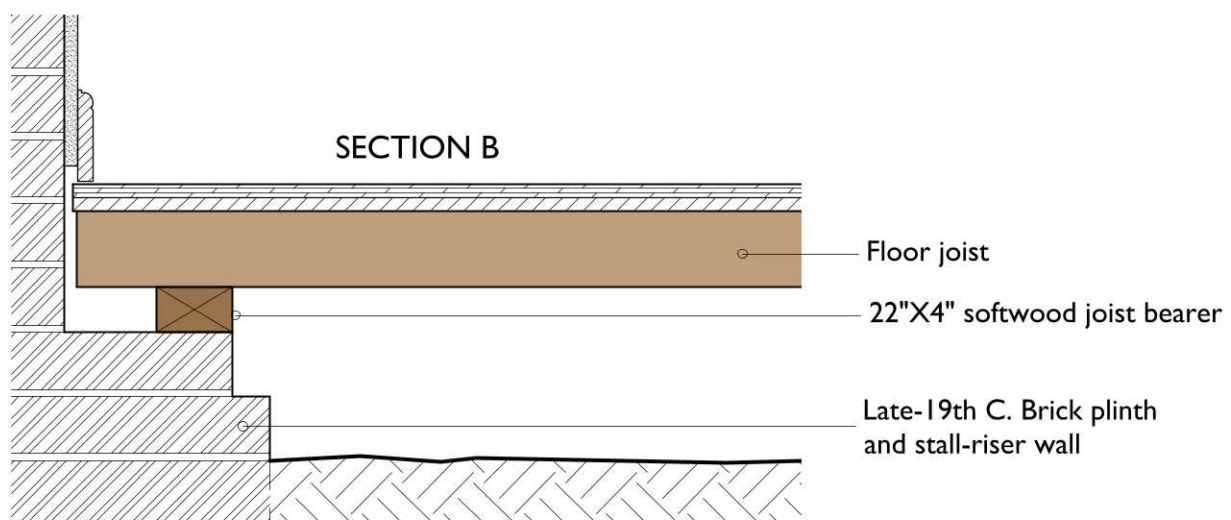
Appendix A

The investigation also revealed that fungal decay induced by moisture (i.e. wet rot) had damaged the floorboards in the area, the ends of three floor joists and the wall plate onto which they bear; to the extent that they had failed, resulting in the noticeable weakness in that area of the floor. The decay had not spread into the adjacent building fabric but was present on the surface of the timber wall post in the same area, but the post was strong at the surface and into the core and was not damaged or weak.

The location and nature of defects discovered in the investigation are shown in *Appendix A* of this document.

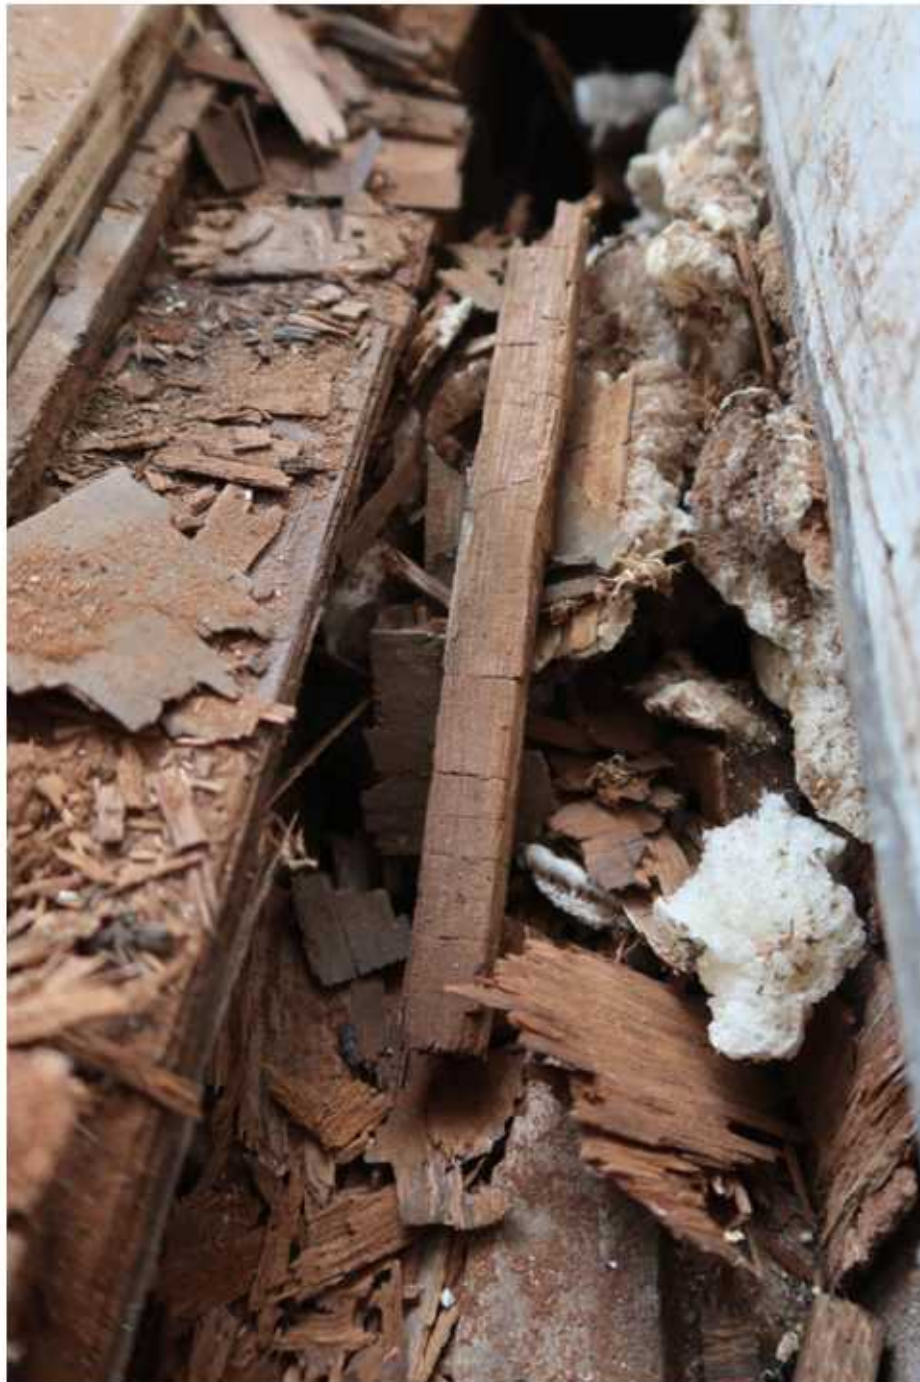
Image A: during removal of the floorboards, showing rotten existing boards (NB - the white foam on the right is expanding foam insulation)

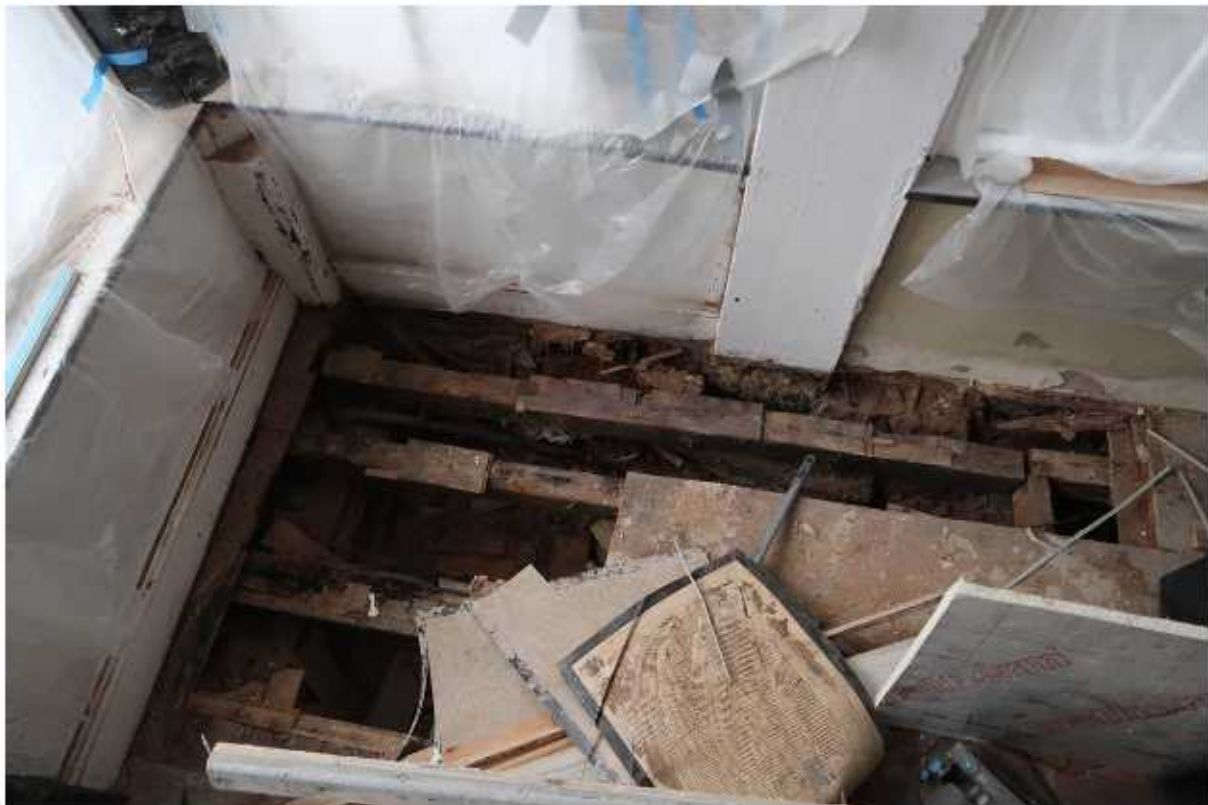
Image B: The area of exposed floor structure – the boards and plywood are lifted

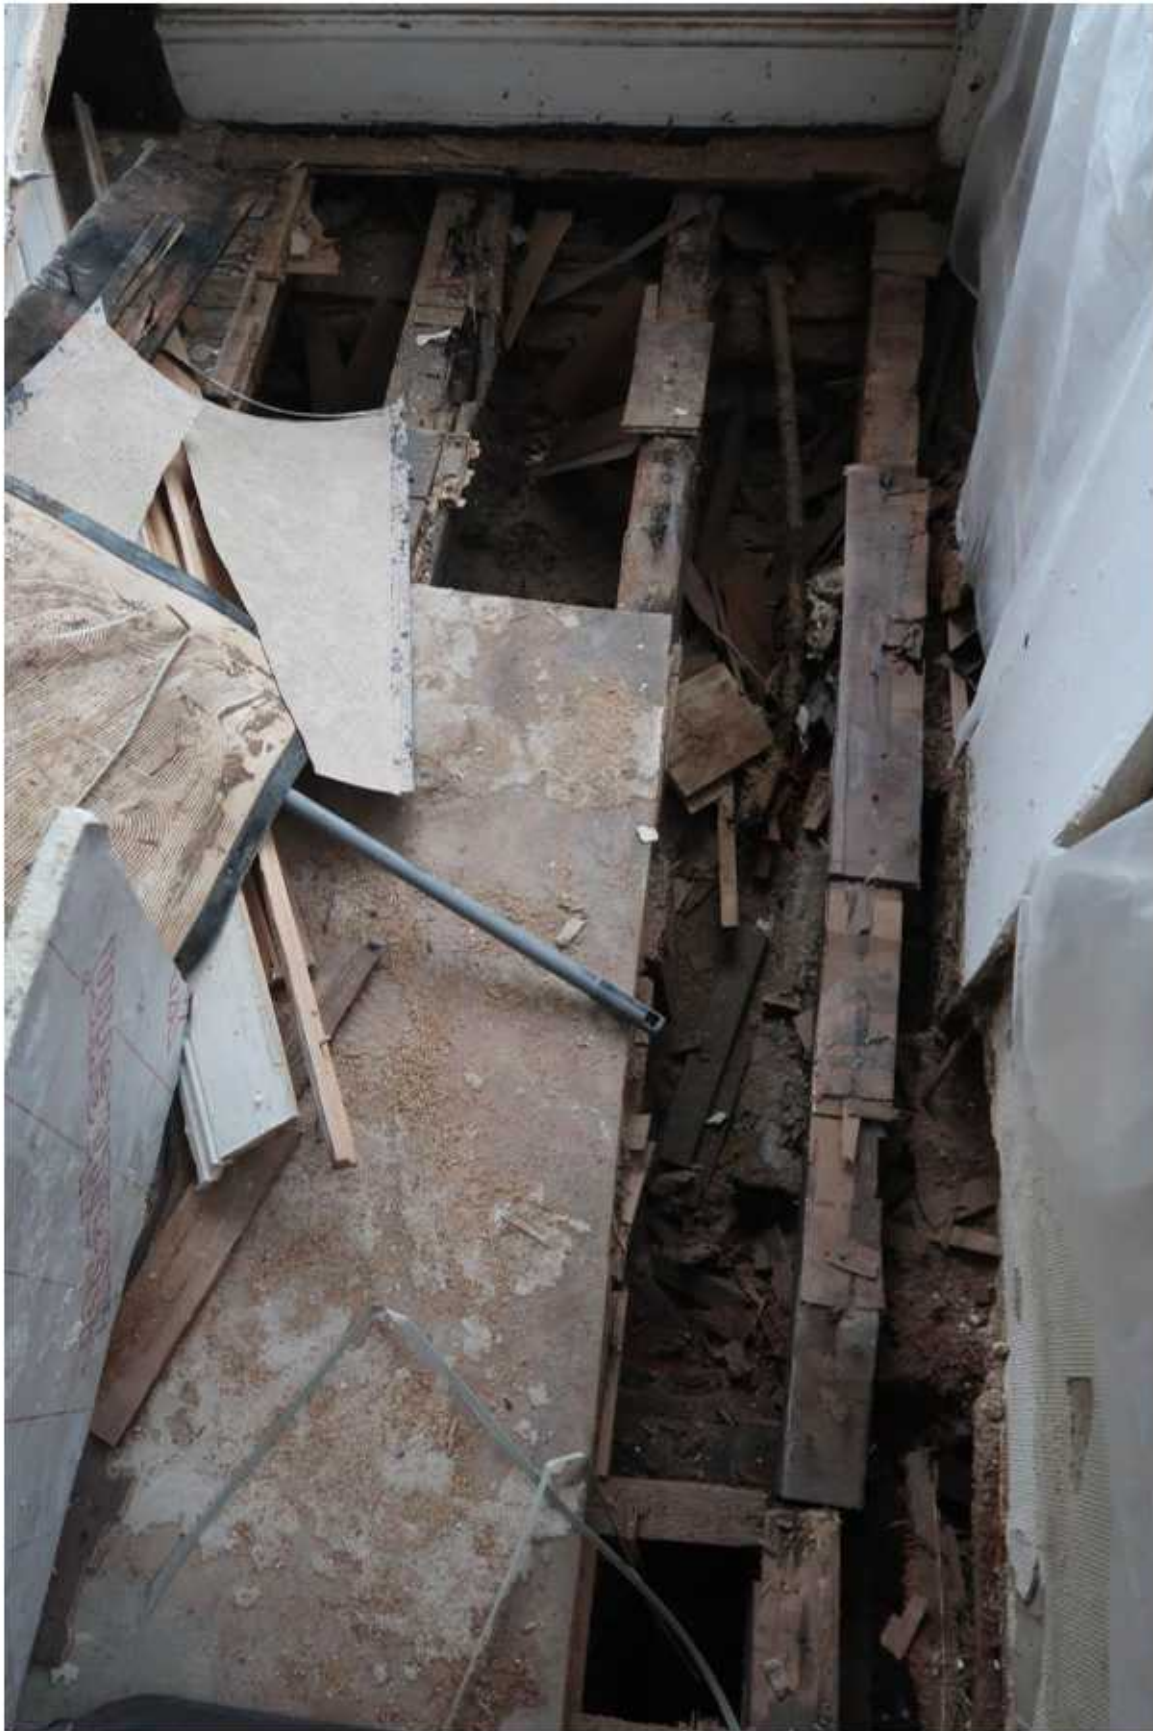
Image C: The exposed floor structure – Boards and plywood are lifted showing the joists and void

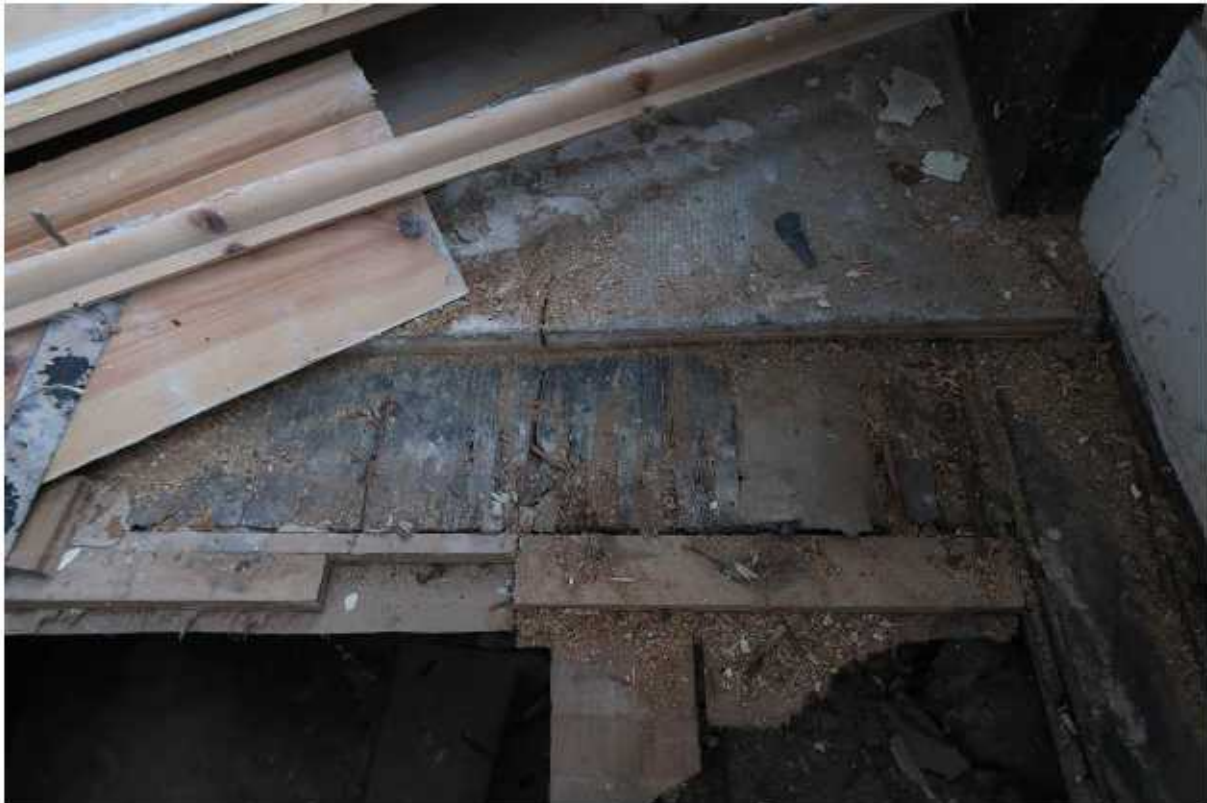
Image D: The earlier floorboards exposed, with later softwood patching visible.

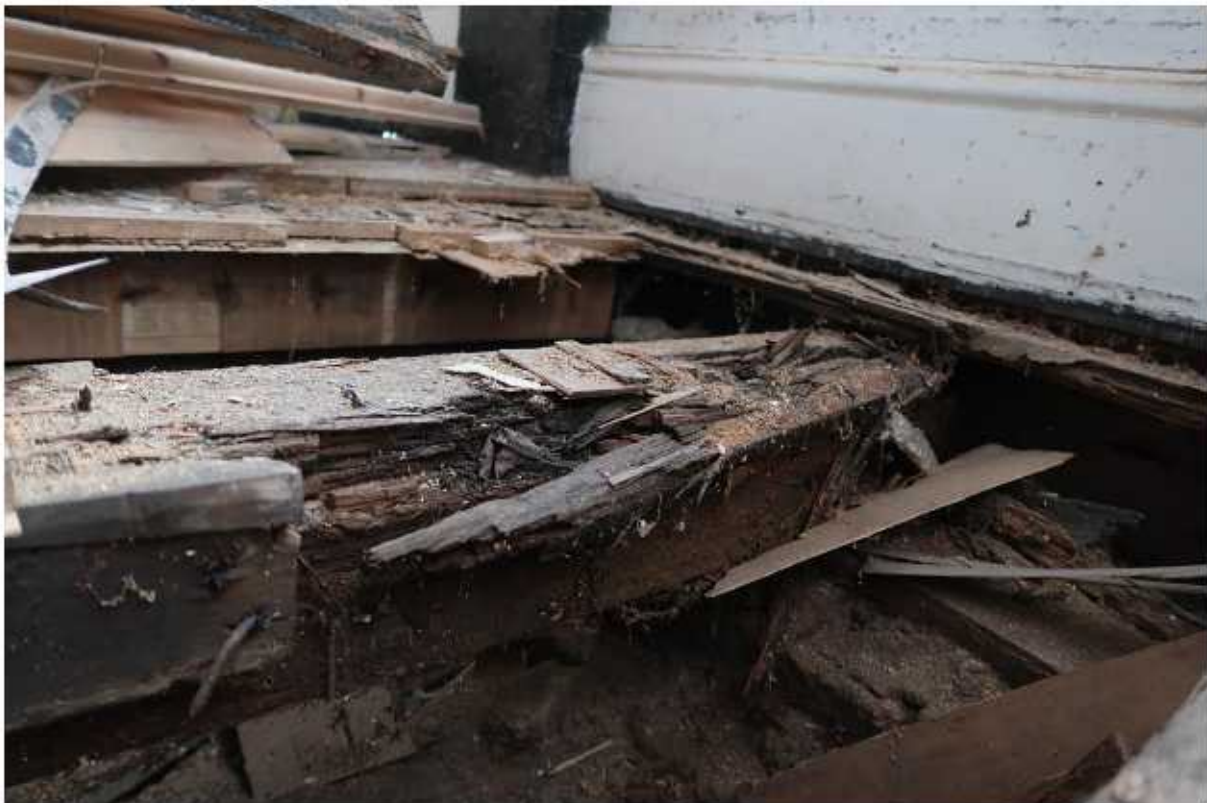
Image E: A floor joist with damage caused by wet rot

1. The rot-damaged sections of the joist identified in Appendix A will be cut away and replaced with a tanalised section of softwood of the same dimensions fixed to the side of the remaining floor joist.
2. The rotten section of joist bearer will be and replaced with a tanalised section of softwood of the same dimensions, in the same position.
3. The exposed wall post and all timber in the area of the fungal infestation will be treated with fungicide to kill any existing fungal decay and prevent fungal attack.
4. Existing undamaged floor floorboards will be reinstated to their original positions and those rendered irreparable by rot will be replaced like-for-like with tongue and groove softwood floorboards.
5. A plywood floor will be fitted over the whole area.
6. A layout and details of the proposed repair work are provided in Appendix C of this document.

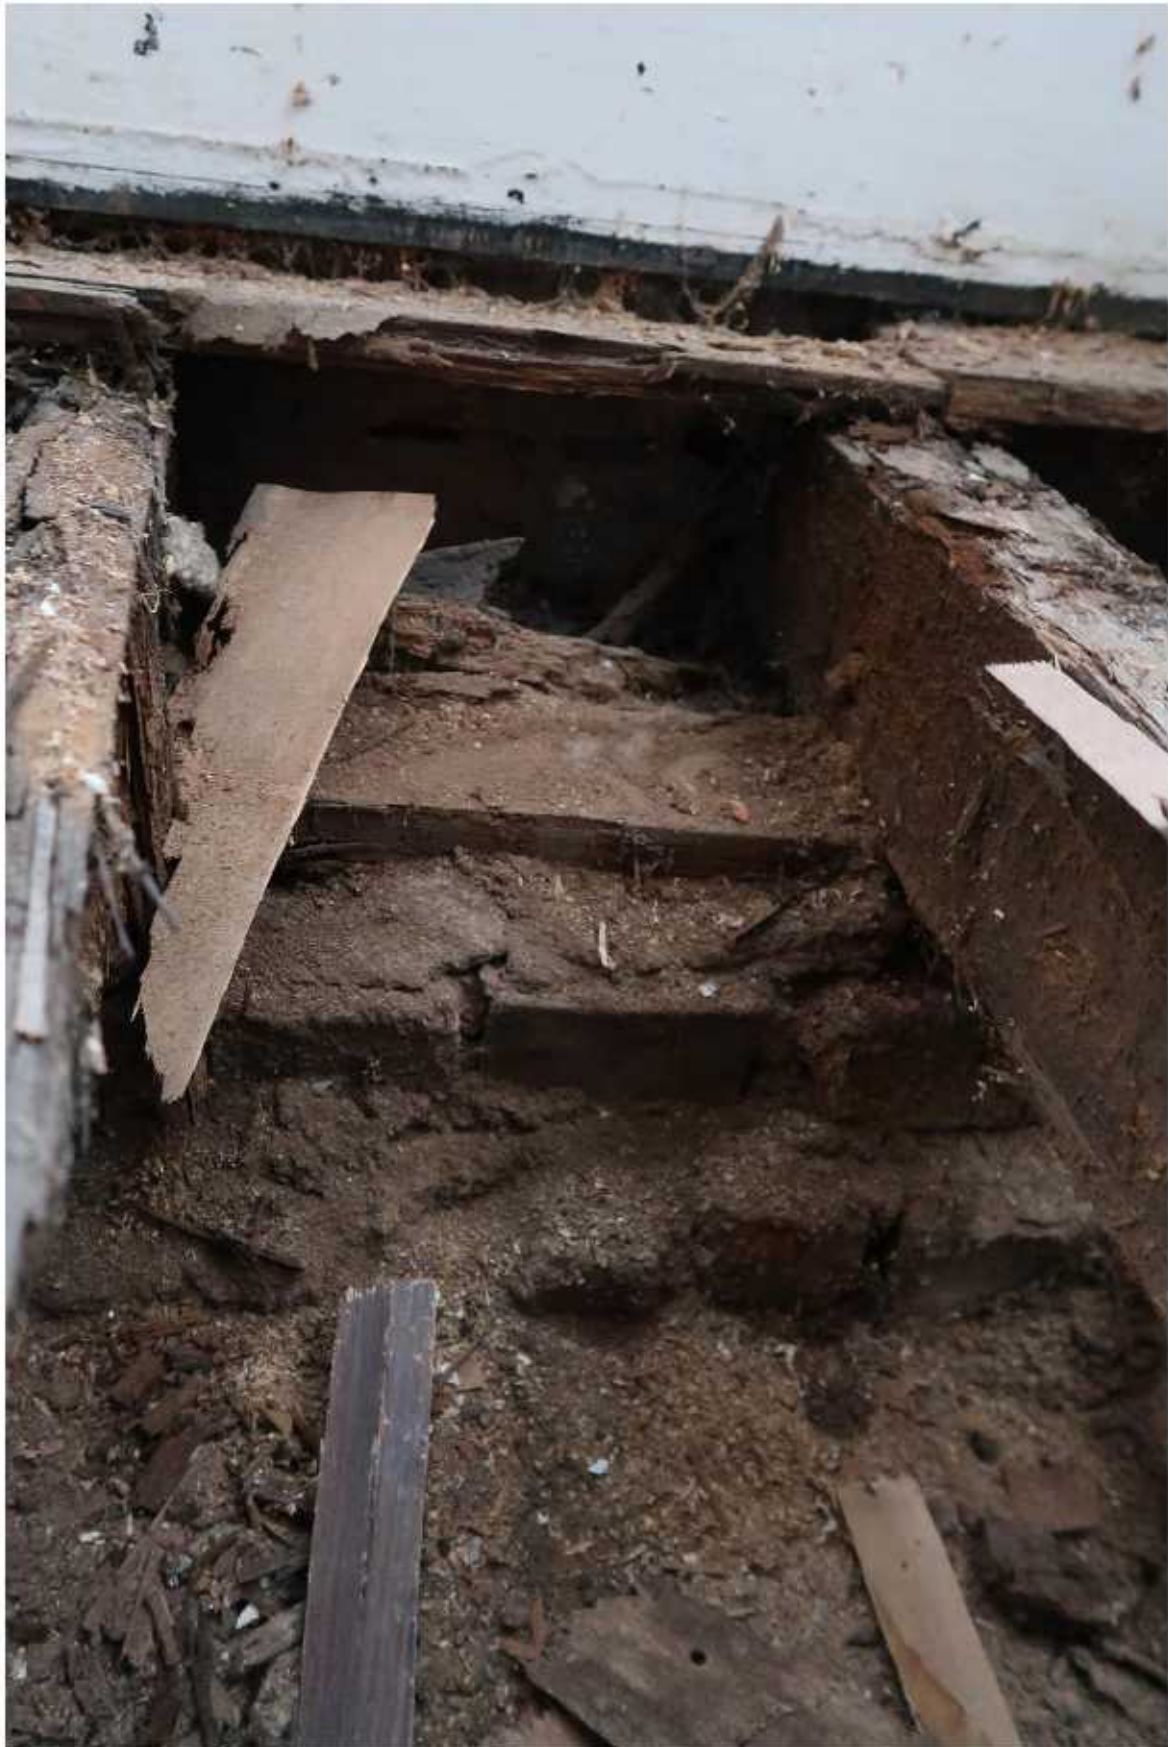
Image F: The joist bearer damaged by wet rot, laid onto the brick plinth wall

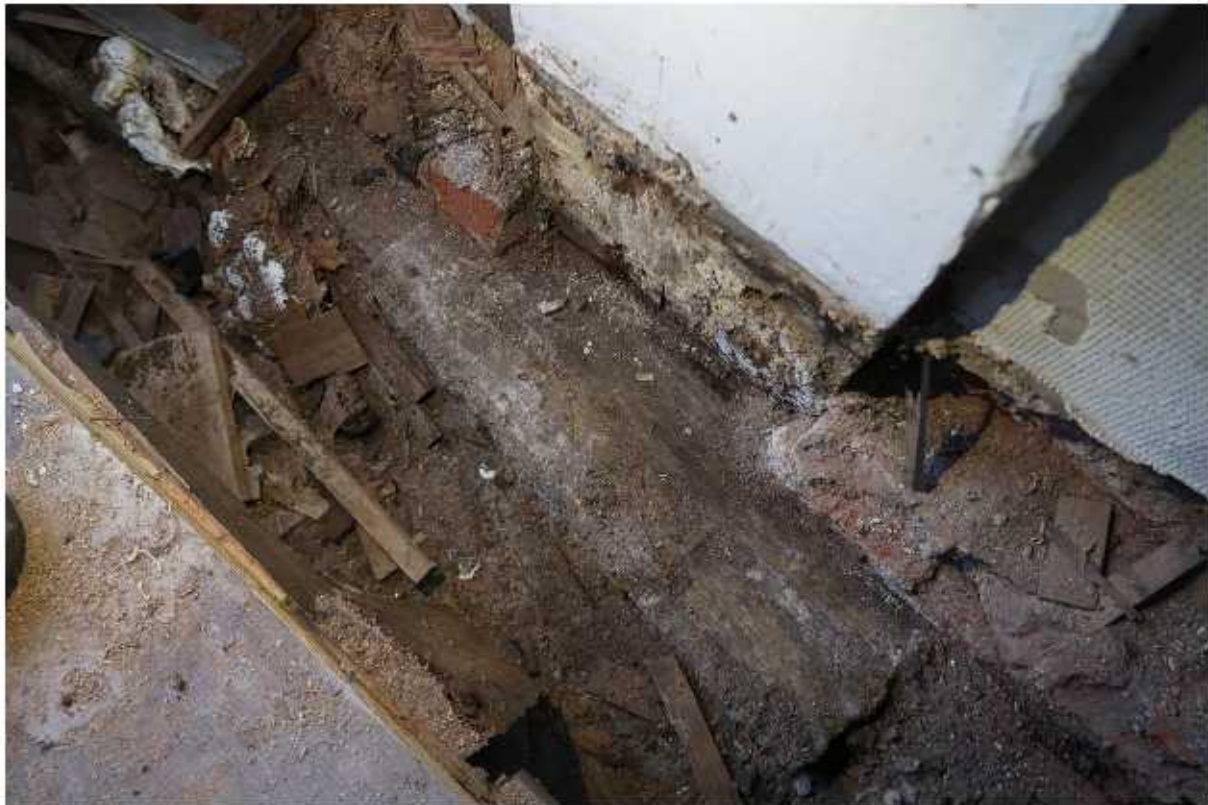
Image G: The oak wall-post footing stone in the sub—floor void

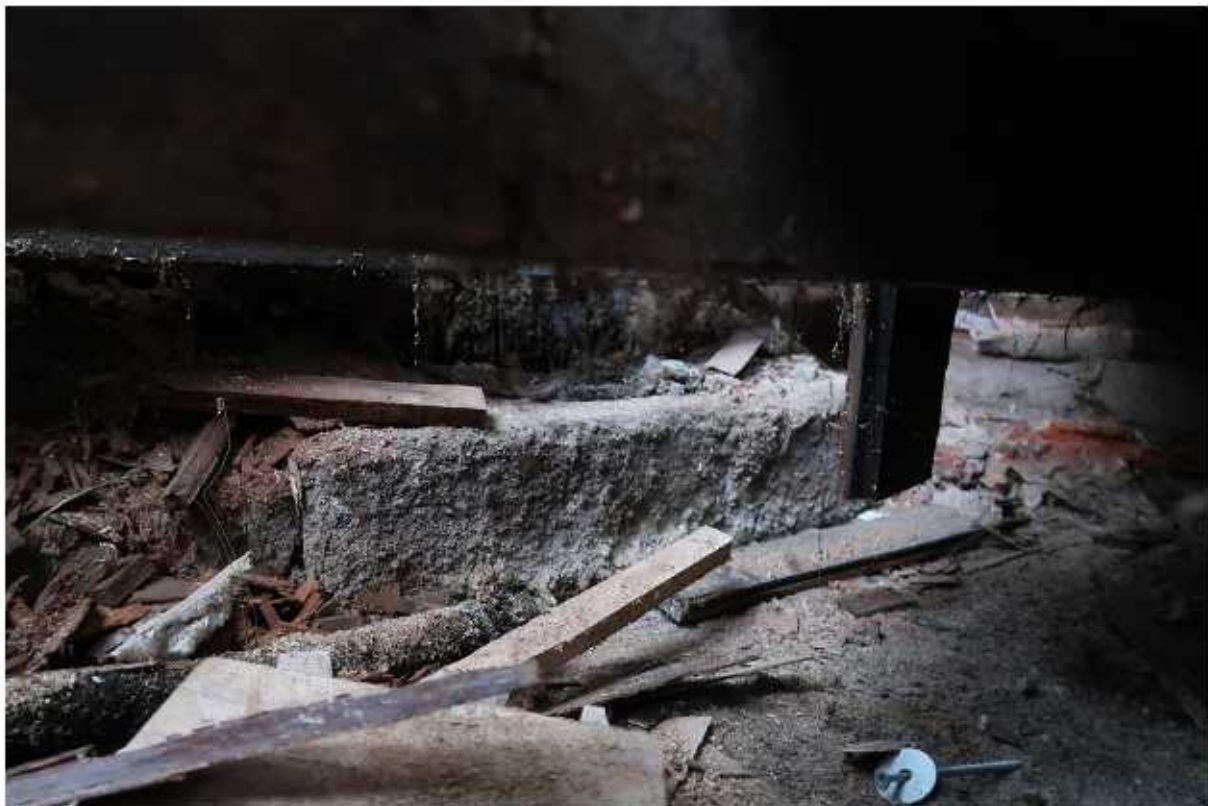
Image H: The oak wall-post footing stone, also showing the sub-floor void and sleeper wall
