Structural Appraisal Report

**The Cottage,
Common Lane,
Old Leake,
Lincolnshire**

Property:-	The Cottage, Common Lane, Old Leake, Lincolnshire. PE22 9RH	Instructed:- July 2020
Client:-	Mr Elsam c/o Neil Dowlman Architecture Ltd. 14 Main Ridge West Boston Lincolnshire PE21 6QQ	Survey & Report by:- J. Ellington BSc. CEng MStructE, FRSA MIOd J. Hicks BEng(Hons) MSc PgDipCHE, MIOd
Reference:-	JC/20/07/5555	Issued:- Aug 2020

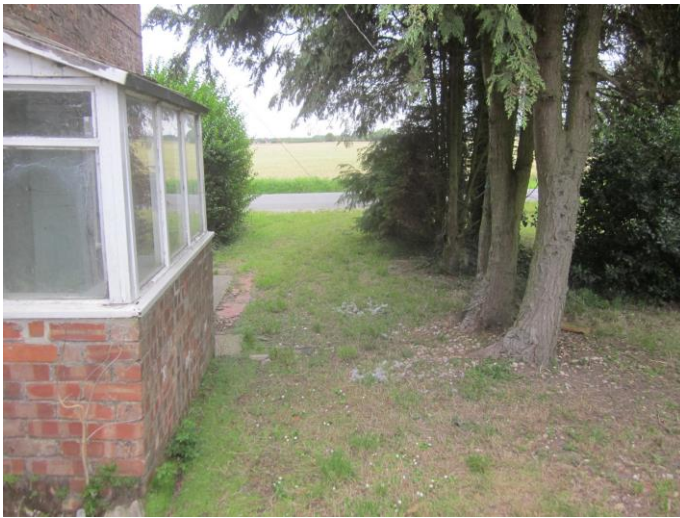
Side Elevation – Adj Trees

- Significant settlement and differential movement noted.
- The movement and defects noted to the superstructure suggests that the foundation system is unable to accommodate and distribute the loading of the building.
- Trees are close to the front / side elevation.

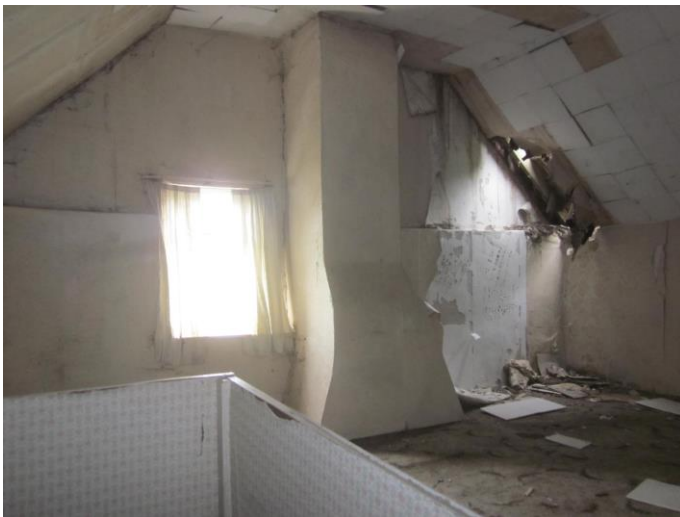
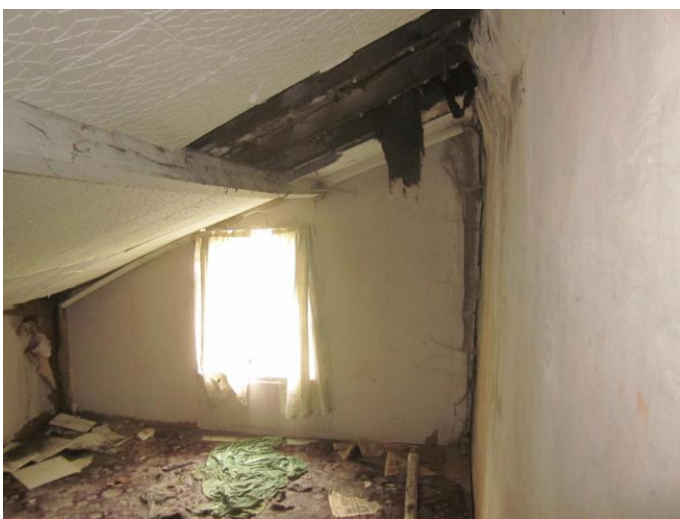
Cottage - Typical Internal – Roof / First Floor

- The ridge line displays significant unevenness along its length.
- The roof slopes are dished (sagging).
- Small areas of missing / slipped tiles.
- Internally there were areas of defective / sagging ceilings.
- Ceiling finishes were missing in parts.
- Sagging purlins noted to mono-pitch roof.
- Defective rainwater goods.

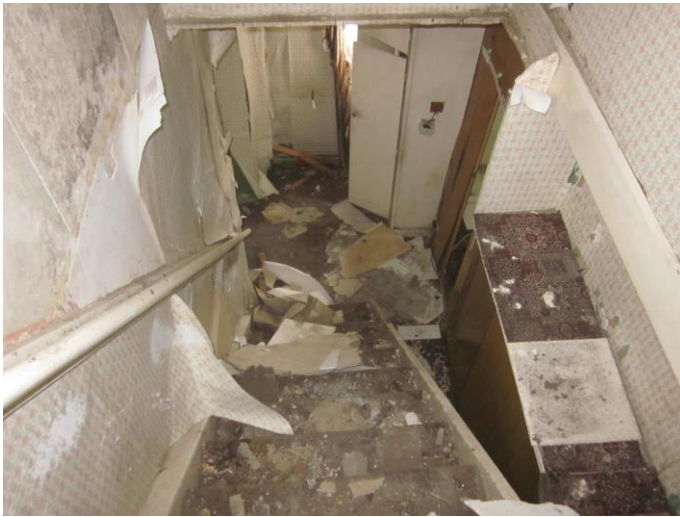
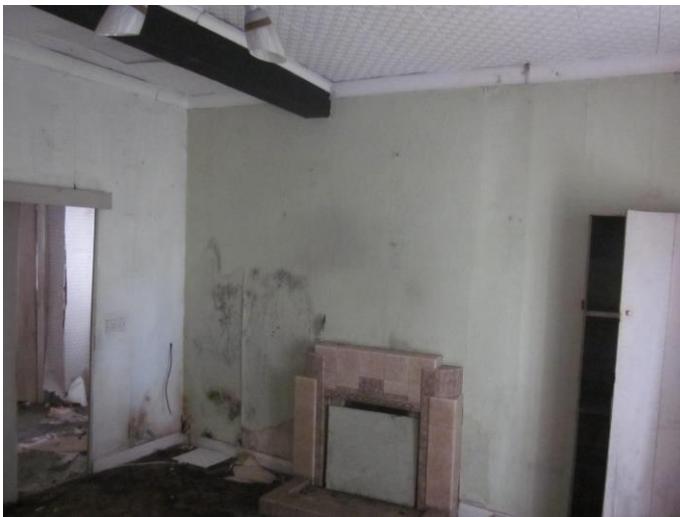
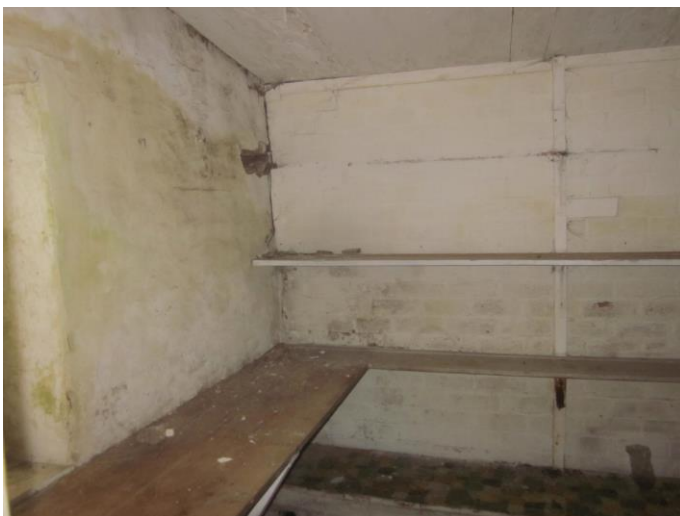
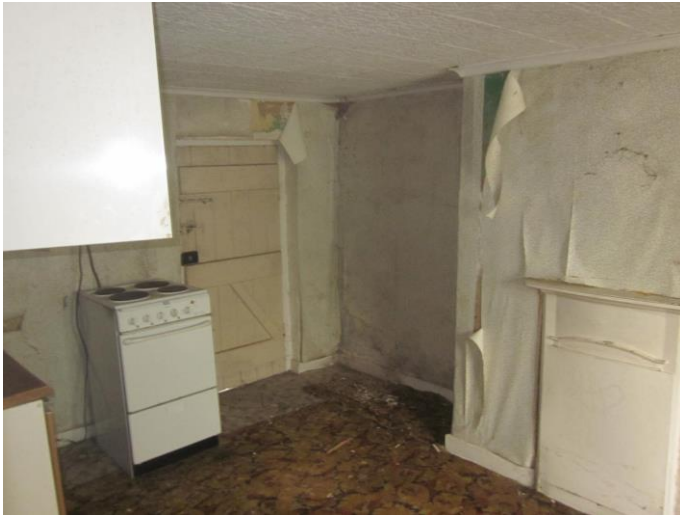
Cottage - Typical Internal – Ground Floor

- Ground floors display significant amount of movement, with unevenness / settlement noted throughout.
- Wall and ceiling finish debris throughout.
- First floors were partially inspected but considered un-safe for general walk over.
- Wall and ceiling finish debris throughout.

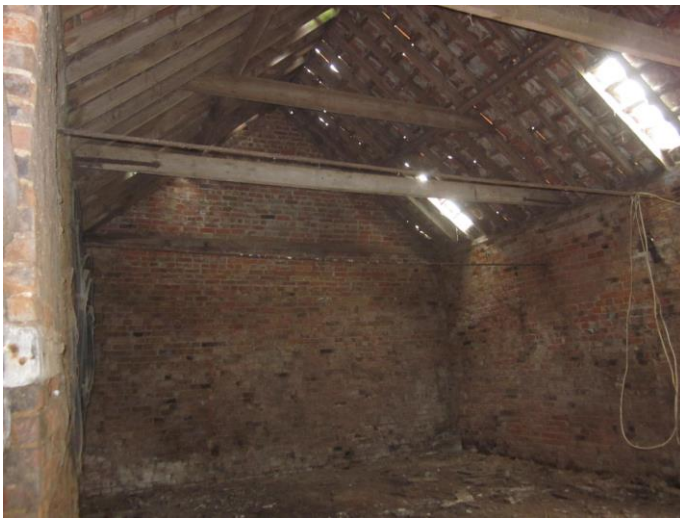
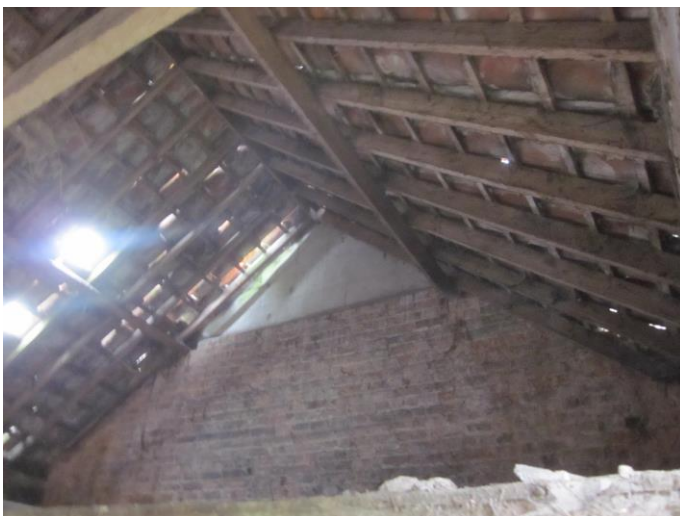
Barn - Typical Internal – Roof / Walls

- The ridge line displays a degree of unevenness along its length.
- The roof slopes are dished (sagging).
- Small areas of missing / slipped tiles.
- Roof timbers and rafters displaying evidence of deflection and bending.
- Defective rainwater goods.

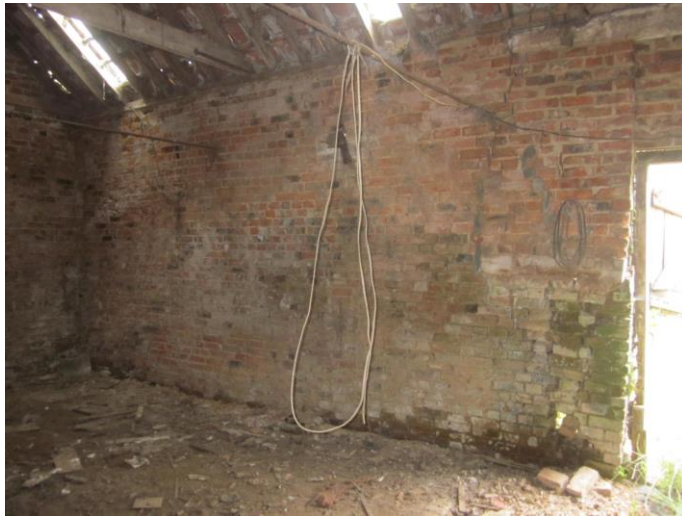
Barn - Typical Internal – Walls

- Side elevation walls are leaning outwards – roof spread.
- Large areas of the side elevation have eroded / perished masonry units.
- Evidence of cracking throughout the elevations.
- Tie bars noted.
- Evidence of vertical movement to all elevations. Bed joints display large amounts of horizontal variation along their length.
- Elevations covered in Ivy growth in parts.
- Lower levels of masonry are damp.

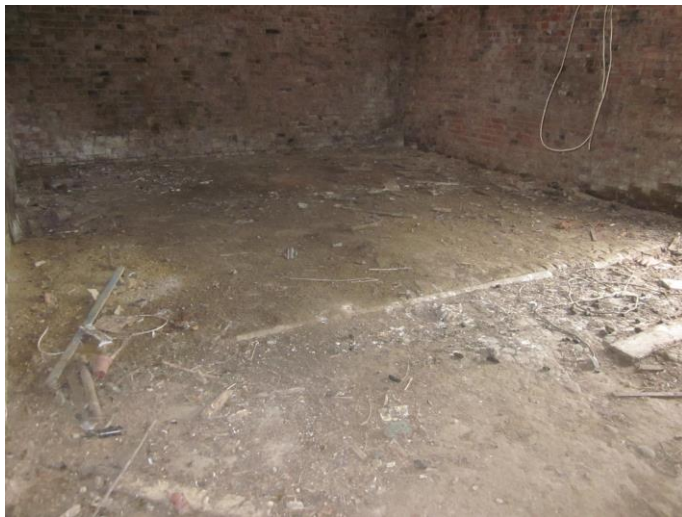
Barn - Typical Internal – Floors

No floors are present in the barn.
