STRUCTURAL APPRAISAL REPORT

**Barn At Rectory Farm
Great Fen Road,
Boston,
Lincolnshire.**

Our Ref;- JC/21/01/5861

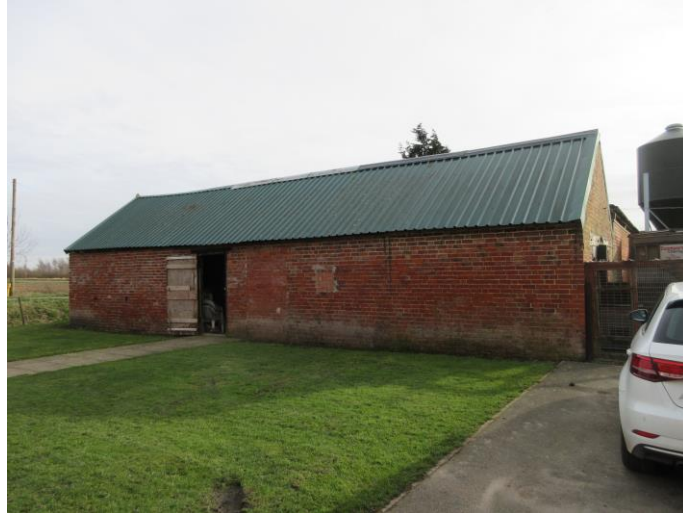
Photograph # 1
(North Facing Elevation)

- Minor fractures to masonry panels throughout.
- Lateral 'outward' movement to the upper section of the Elevation.
- Localised areas of infilled previous door / window opening.
- Localised areas of previous hard cement repointing.
- No guttering present guttering. – Evidence of splashback damage at lower levels of wall adjacent ground level.

The upper section of the North Elevation wall has suffered a degree of lateral 'outward' movement, which is likely to be the result of the defective roof structure. Allowance for localised rebuilding of walls at eaves level should be incorporated into the conversion scheme to this elevation.

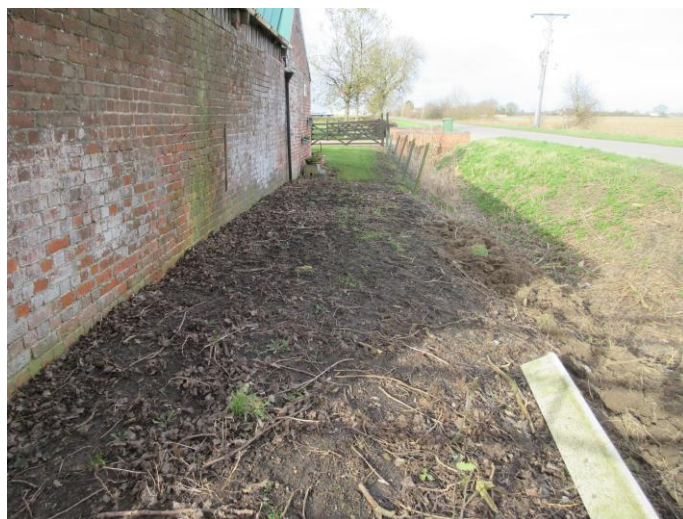
Photograph # 3
(East Facing Elevation)

- Minor fractures to masonry panels throughout.
- Considerable lateral 'outward' movement and bulging to the gable of the Main Single Storey Duo Pitched Barn.
- Lateral 'outward' movement to the upper section of the East elevation wall of Open Fronted Mono-Pitch Barns, below the timber infill panel. This is located where the wall reduces in thickness.

The East elevation gable wall has accommodated lateral 'outward' movement. Architectural schemes indicate that this gable is to be reconfigured as a glazed gable, which will provide the opportunity to locally repair any remaining fabric to this gable.

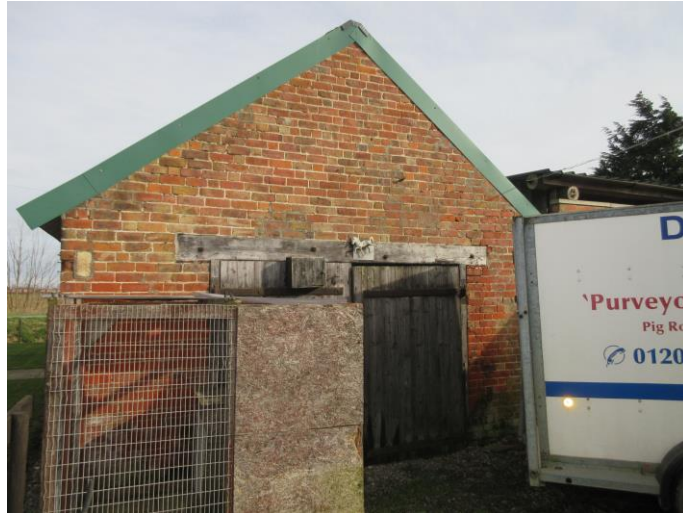
Photograph # 4
(Part West Facing Elevation)

- No significant defects noted.
- Gable incorporates a large timber door with timber lintel over.
- Localised areas of previous hard cement repointing.

The West elevation gable wall did not display any noticeable defects and should not require any significant intervention.

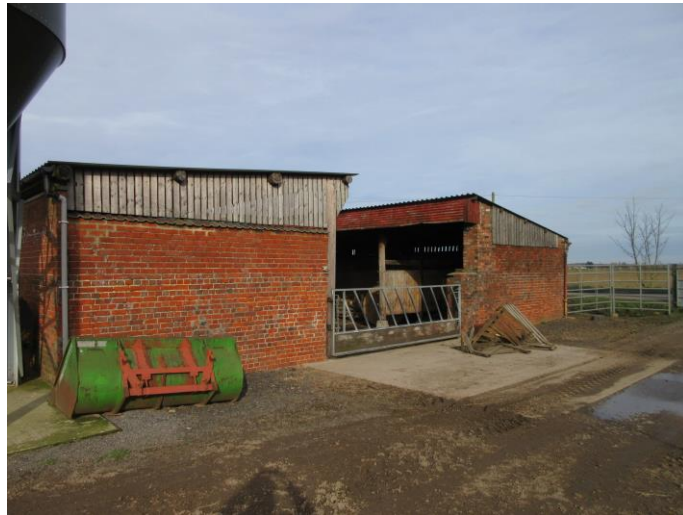
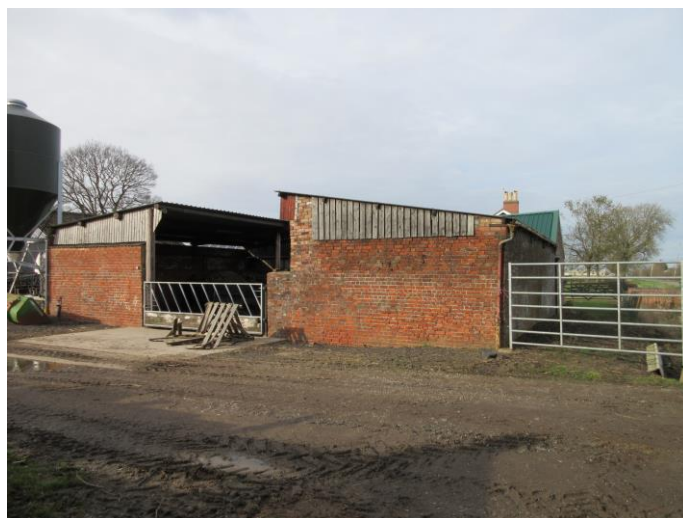
- Lateral 'outward' movement to the upper section of the right hand gable elevation, below the timber infill panel. This is located where the wall reduces in thickness.
- Localised areas of previous hard cement repointing and previous local rebuild.
- Open joints to brickwork noted throughout.

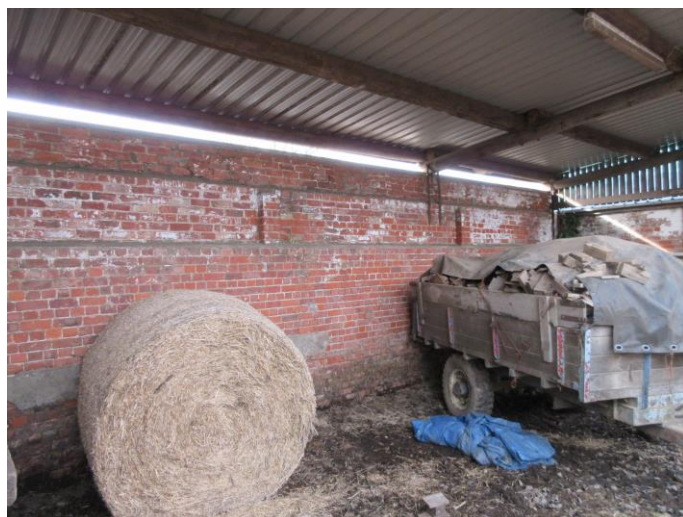
Photograph # 9
(Typical Mono-Pitched Barn Wall)

The walls to the mono-pitched barns reduce in thickness over their height. The lower levels of wall are 440mm wide, fully bonded, reducing to 215mm wide at the upper section of the walls, and finally reducing to half brick thick at eaves.

It is envisaged that the thicker sections of the wall on all elevations can remain with little intervention required. The upper reduced section of the East and West Elevation walls has suffered a degree of lateral 'outward' movement. Allowance for localised rebuilding of walls at eaves level, as part of the proposed high-level window arrangements should be incorporated into the conversion scheme on all elevations.

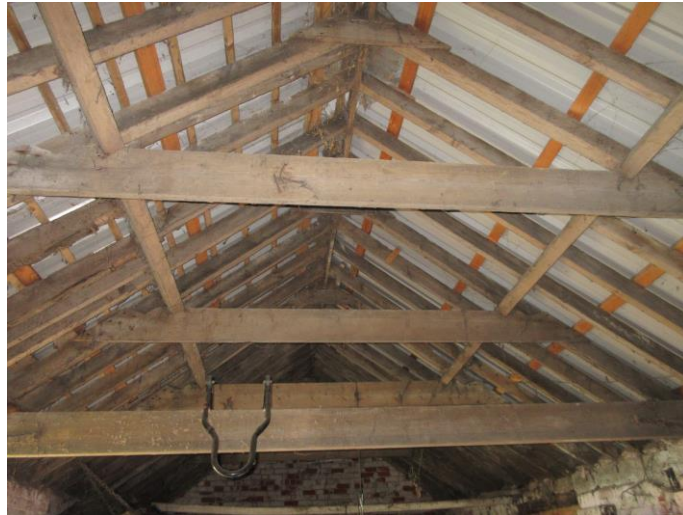
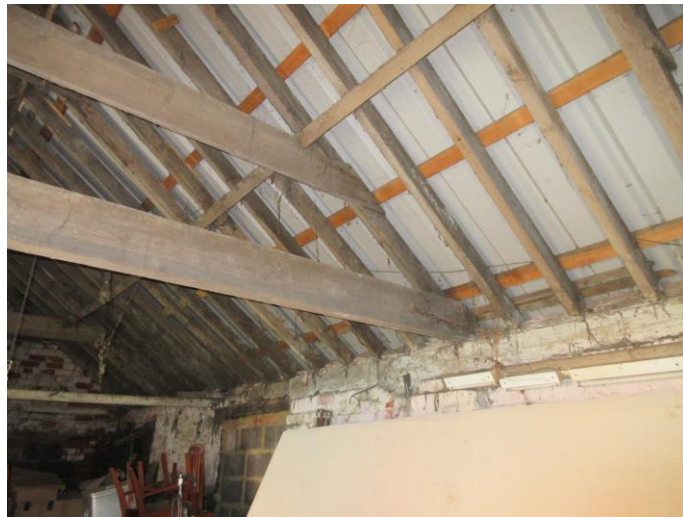
The original roof structure has been previously over roofed and currently supports a lightweight corrugated sheeting material. There was evidence that the original roof structure had become distorted, with slight racking to timbers evident. It is unlikely that in its current arrangement the existing roof structure would be able to support a reinstated slate / tiled roof covering, insulation and ceilings envisaged as part of any conversion, without further distortion.

Attempting to strengthen existing roof elements is possible, however a replacement roof would reduce the degree of stresses on the existing supporting walls and will prove to be the most practicable solution. We therefore recommend that consideration is made for a replacement roof structure as part of any conversion scheme.

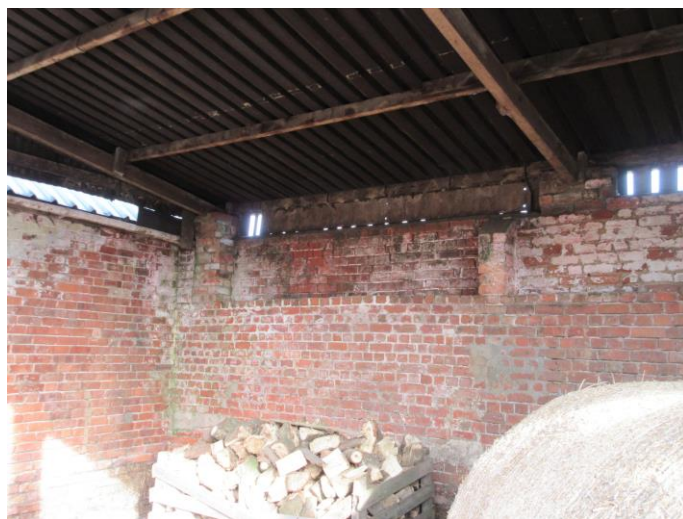
Photograph # 12
(Typical Roof – Mono-Pitched Barn)

The roof structure currently supports a lightweight corrugated sheeting material. Existing timbers are unsuitable to remain as part of any conversion.

New mono-pitched roof structures will need to be incorporated as part of any conversion scheme.

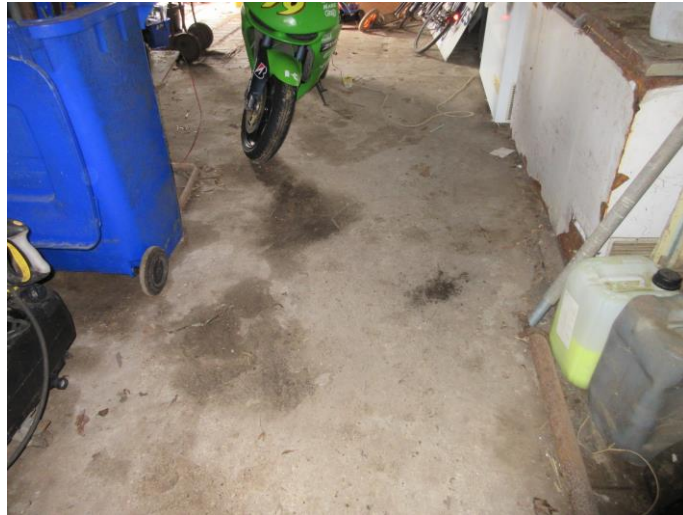
Photograph # 13
(Floor Slab Duo-Pitched Barn)

- There is a part concrete slab within the main single storey barn, specification of which is unknown. Various changes in levels.
- Floor covered with various stored material throughout – inspection limited.
- The open fronted barns have some areas of brick sets forming hardstanding, but no floors present. The remainder being an earth-based crew yard.

- 6.6.1 The existing concrete floor slab in the Main Single Storey Duo Pitched Barn is of unknown specification and no ground floor slabs are currently present in the Open Fronted Mono-Pitch Barns. As such, a new floor slab is required throughout and therefore allowance should be made for the installation of a new ground bearing, concrete ground floor slab to typical architects' specification, incorporating suitable damp-proof systems, insulation and screeds as required. If the floor slab is to be utilised as providing support for the new inner leaf wall (as recommended in item 6.5.6 of this report) then it should be engineer designed as a reinforced concrete flat slab to ensure that it can safely accommodate and distribute the loadings applied.
