STRUCTURAL APPRAISAL REPORT

Existing Barn;-
Claydyke Barn,
Off Martins Cross Drove,
Amber Hill, Boston,
Lincolnshire.
PE20 3RQ

Our Ref;- JC/21/05/6056

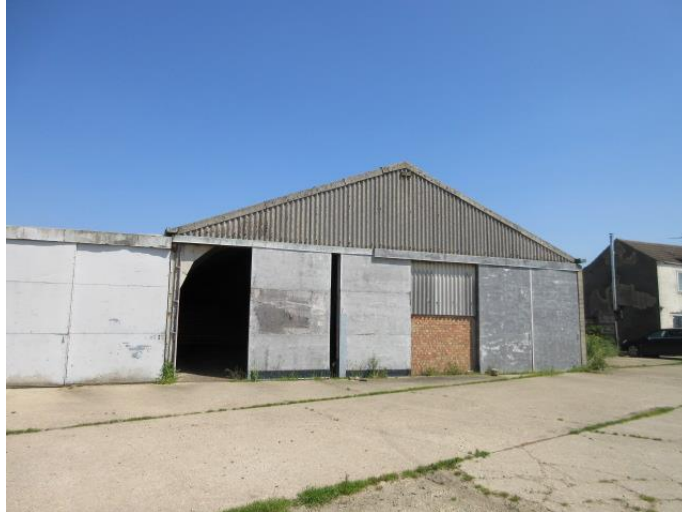
- Externally, the upper profiled cladding is in reasonable condition.
- When viewed along their length, elevation and gable, columns appeared plumb and vertical and are not showing signs of distress.
- Internally much of the brickwork walls were hidden by a temporary profiled insulated sheeting system that had been installed, however where they could be inspected, they displayed little signs of defect. When inspected externally, the brickwork walls displayed little signs of defect or movement. Minor defacing of brick units was noted to localised areas of the external rear corners; however, their condition is typical of agricultural use to a building of this age.

Photograph # 1 (Typical Elevation)

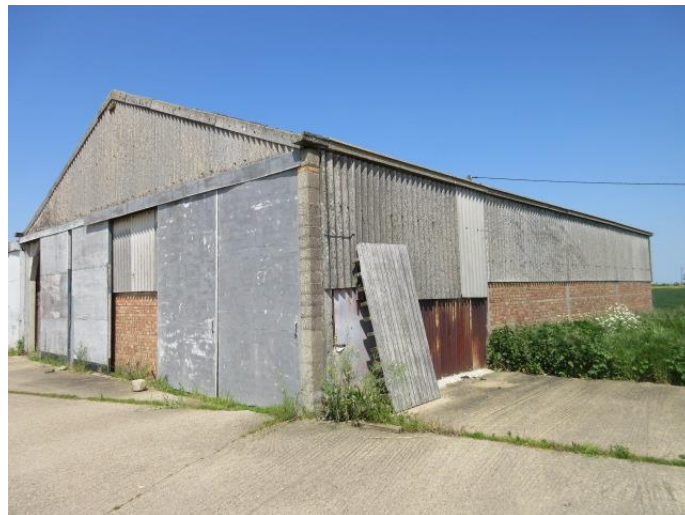
Photograph # 2 (Typical Elevation)

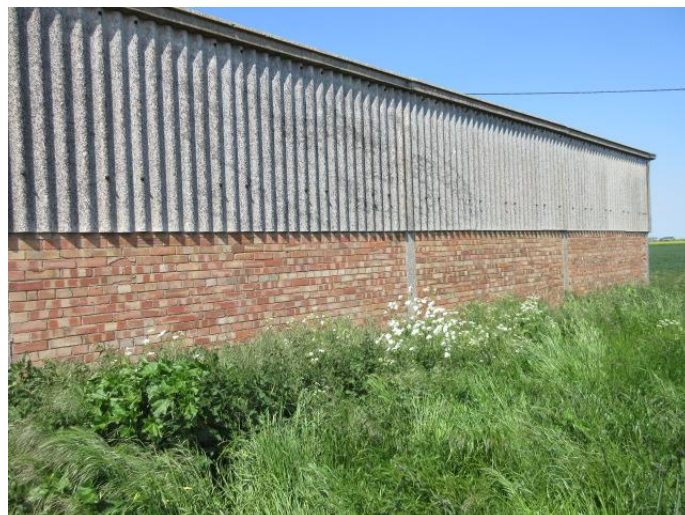
Photograph # 3 (Typical Elevation)

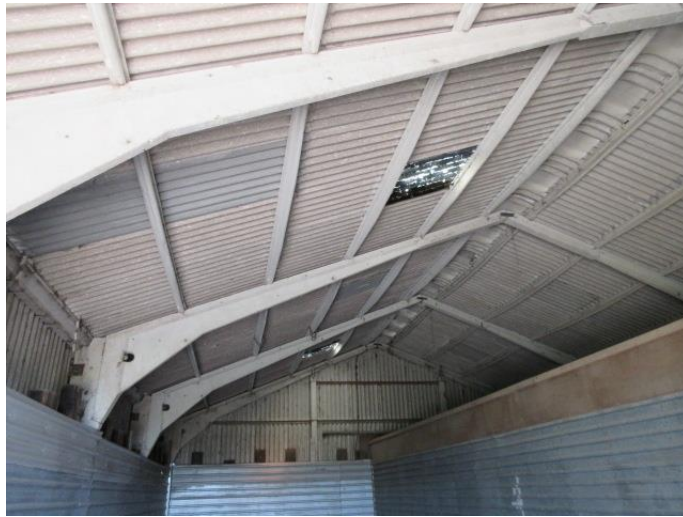
- Portal rafters and columns, appear in good condition, with no signs of distress or concrete spalling.
- The frames appeared plumb with no distortion or deflection of members noted.
- Concrete roof purlins are in sound condition and did not display any excessive spalling or deflection along their length.

Photograph # 4 (Typical Existing Frame)

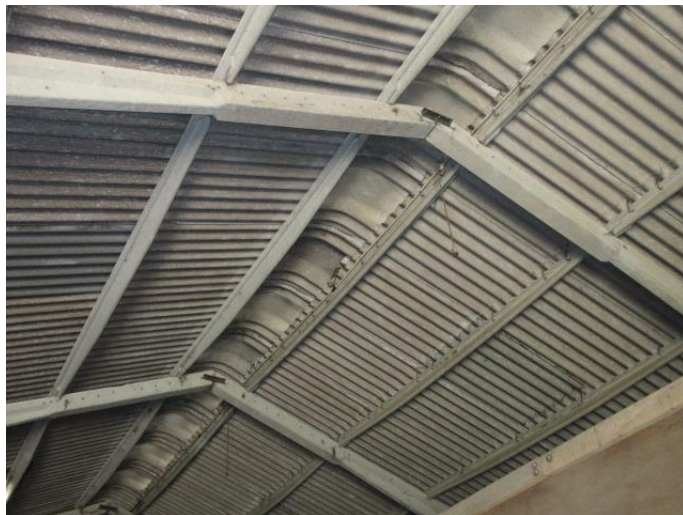
Photograph # 5 (Typical Existing Frame)

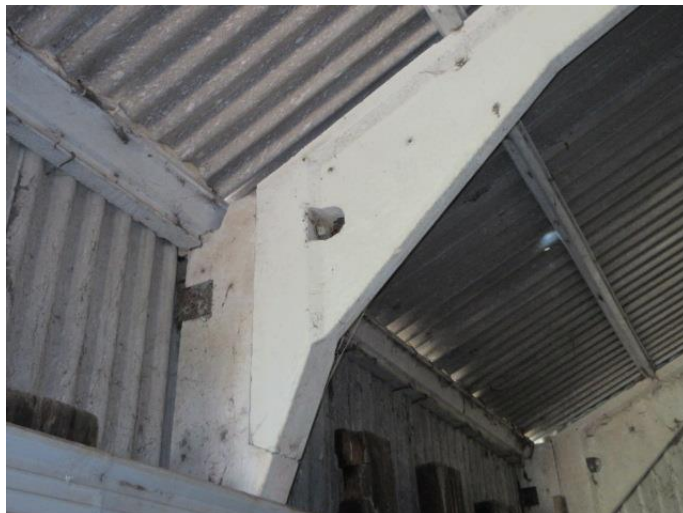
Photograph # 6 (Typical Existing Frame– Eaves Haunch)

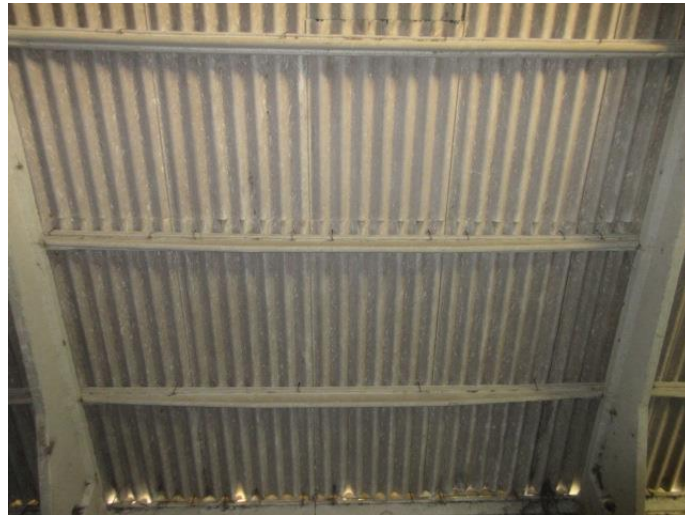
Photograph # 7 (Typical Purlins)

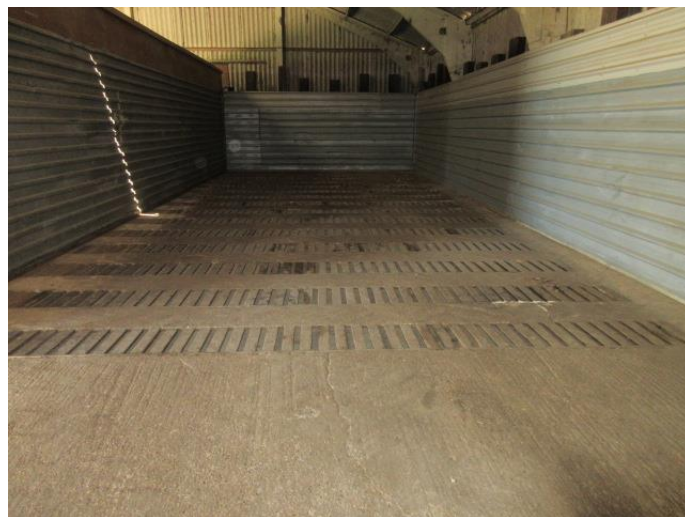
- The concrete floor is of unknown specification. No major fractures were observed to the area of floor that could be inspected
- A large part of the building accommodates a raised timber 'drying floor' that will have been installed over the concrete floor however, its specification is unknown. Typically this type of arrangement generally protects the lower concrete slab from long term deterioration.

Photograph # 8 (Typical Raised 'Drier' Floor)

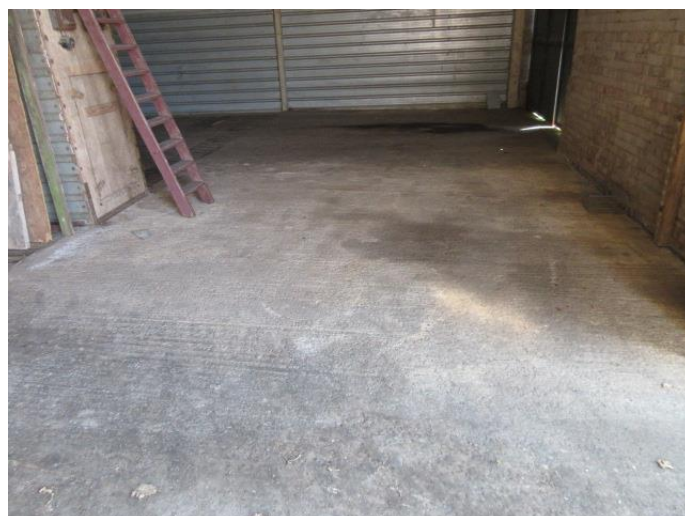
Photograph # 9 (Typical Slab)

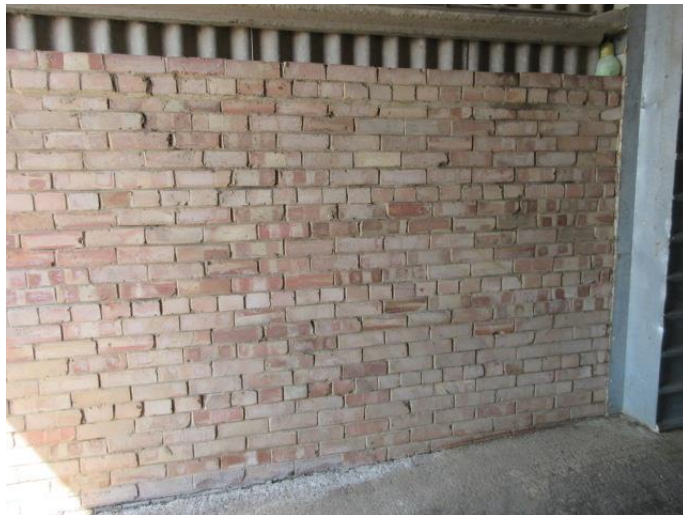
Photograph # 10 (Typical Internal Brickwork)

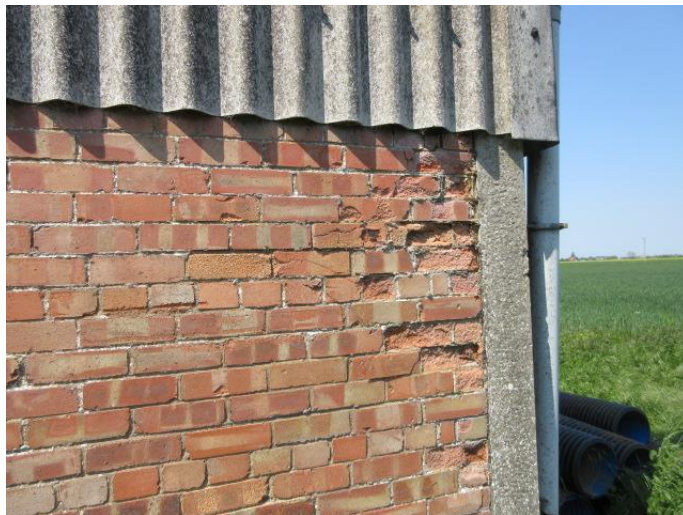
Photograph # 11 (Typical External Brickwork – Isolated areas of defaced masonry)

- 5.8 There are no essential repairs required to the existing fabric in order to guarantee its overall stability. Some low-key, superficial repairs will be required to any damaged wall fabric / wall sheeting however it is likely that for aesthetical purposes, a replacement sheeting system will be adopted during architectural design and as such any defective wall and roof sheeting can be addressed at this time. Whilst reference to contamination, including the identification and survey of asbestos based materials, is outside the scope of our reports, we must highlight that the use of asbestos materials was common practice during the original construction of these types of building and initial inspections suggest that a large amount of the existing roof and wall sheeting on this building may contain asbestos materials. (See Section 5.10)
