Demolition of the Former Norton Lea Hospital, Boston

Arboricultural Inspection Report - November 2021

B027289

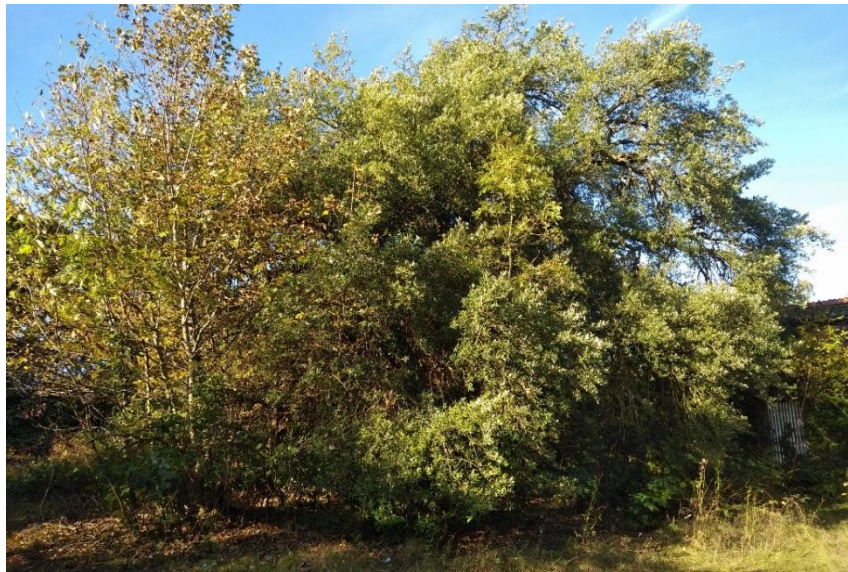
- 3.1.1 The cork oak (*Quercus suber*) tree T37 was inspected in detail. The tree is a large mature tree of considerable character. It was identified as a tree of high quality and value (BS5837 A category) in the previous survey. The tree is of spreading form with heavy lateral branches, with some supported by steel props.

Image 1. Cork oak tree T37.

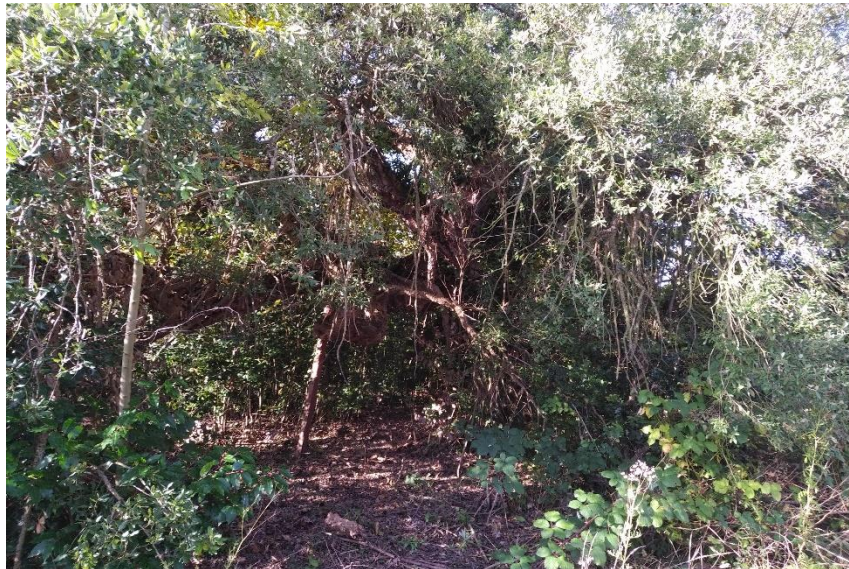
Image 2. Cork oak tree T37, showing heavy lateral branches with props.

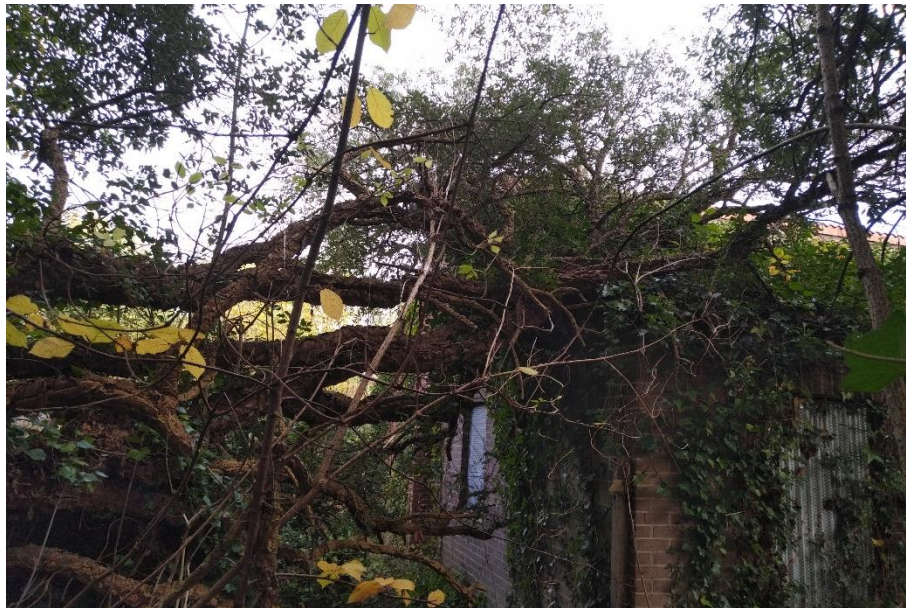
- 3.1.2 A secondary stem on the north side of the tree has partially collapsed, causing a crack at the union with the main stem at 1m. The stem was previously supported by two props, and appears to have collapsed once their support was removed. One of the props has fallen and the other failed with the rusting of plates forming the support cradle at the top.

- 3.1.3 The partially collapsed northern stem is partially resting on the ground and appears to be stable. Part of the crown to the north-west deriving from this collapsed stem is supported by unions in adjoining semi-mature sycamore and laurel trees. The crack in the union has retained a significant strip of intact cambium and the branches beyond appear to be healthy and vigorous. Removal of the partially collapsed stem by cutting at the main stem would create a large wound on the main stem, and it is recommended that the partially collapsed

stem is retained in-situ as it appears to be healthy and stable. The fallen stem may root where it is in close contact with the ground, which will increase its long-term stability and health.

Image 3. Collapsed northern stem on tree T37 resting on building.

- 4.1.3 The partially collapsed stem on the cork oak tree T37 should be retained.

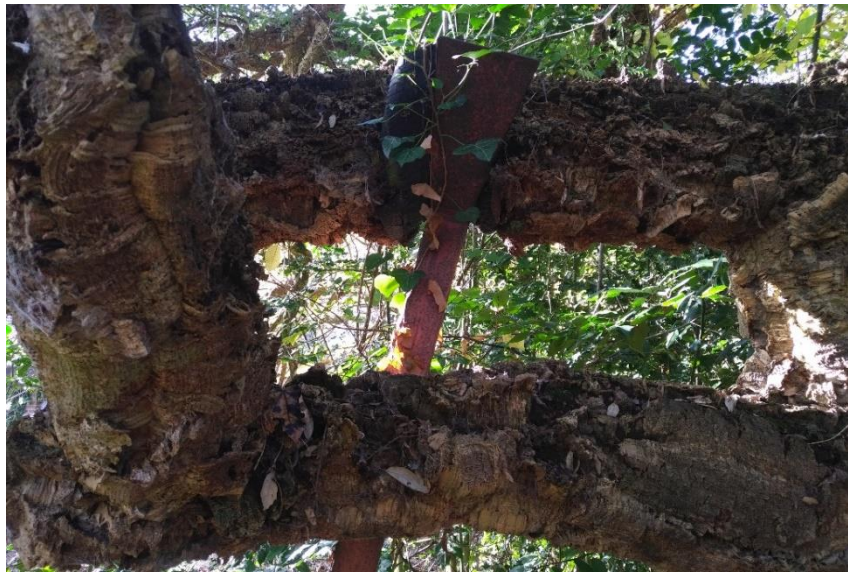
- 3.1.4 Two props remain intact supporting branches and are located at approximately 4.0m south-south-east (2.3m tall) and 3m south-south-west (2.7m tall). The props are welded steel with a 90x90mm square section upright welded to a foot approximately 460x460mm in size. The branches are supported by a V-shaped cradle formed by two plates approximately 380x195x90mm in size. The foot and cradle are formed of 8mm sheet. The props appear to be covered with red oxide or similar protective covering. Strips of car tyres have been placed between the props and branches to form a cushion.

- 3.1.5 The props were examined and appeared to be stable, with no sign of significant or deep rusting, although some rust patches are present. The branches have distorted around the prop cradles.

- 3.1.6 Trees adapt to secondary supports and it is very likely that the currently supported branches would collapse if the props were removed. They should therefore remain. No replacement or adjustment of the props is considered necessary at the moment, but they should be regularly reinspected alongside the tree.

Image 4. Branch of tree T37 supported by prop.

- 4.1.4 The two remaining branch props should remain in-situ. In order to maximise their life span, they should repainted with a suitable red oxide paint, as advised by the contractor in liaison with the Arboricultural Consultant.
- 4.1.5 Once the site works are complete, the branch props should be reinspected every 18 months, on the same reinspection cycle as the tree.

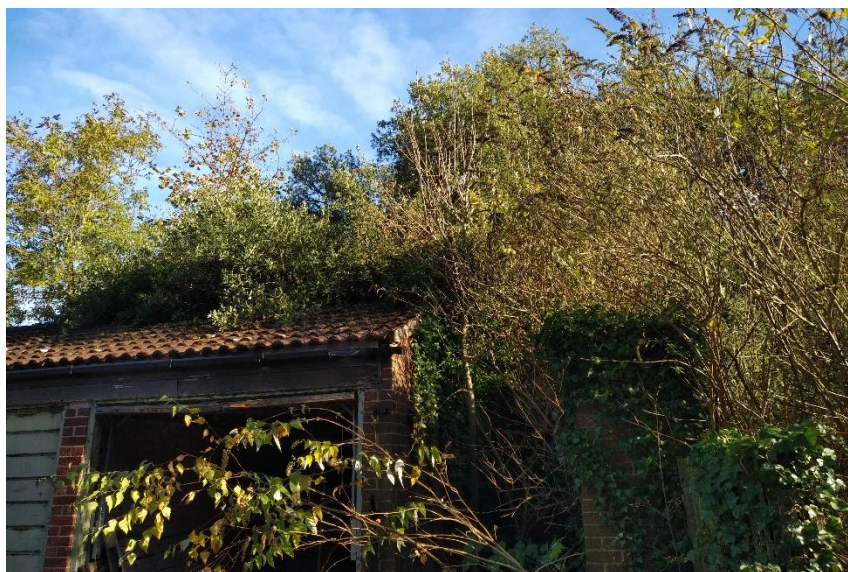
- 3.1.7 Branches from the cork oak overgrow buildings to the north-east and west which are to be demolished. These branches require pruning to allow the demolition to proceed without damage to the tree. The branches overgrowing the single-storey buildings are:
- Branch to north-east, derived from fallen stem, and branch resting on building.
 - Branch to north-west, derived from fallen stem and supported by semi-mature trees.
 - Branch to the west, resting on and supported by building.
 - Branch to the west-south-west, overgrowing but not supported by the building.
- 3.1.8 Each of these branches overgrows the buildings by 2-3m.

Image 5. Branches from T37 lying across the roof to west.

- 4.1.6 Branches that overhang the adjacent buildings should be pruned back to at least 1.0m beyond the building line. The branches should cut at the first side branch available beyond this point.

- 4.1.8 The branch to the west should be provided with temporary support (Acro prop or similar with foam padding as advised by the contractor in liaison with the Arboricultural Consultant) before it is pruned as it is currently strongly supported by the building and may be at risk of collapse once this support is removed. The branch will be reinspected by the Arboricultural Consultant at the next visit to determine whether permanent support is required.

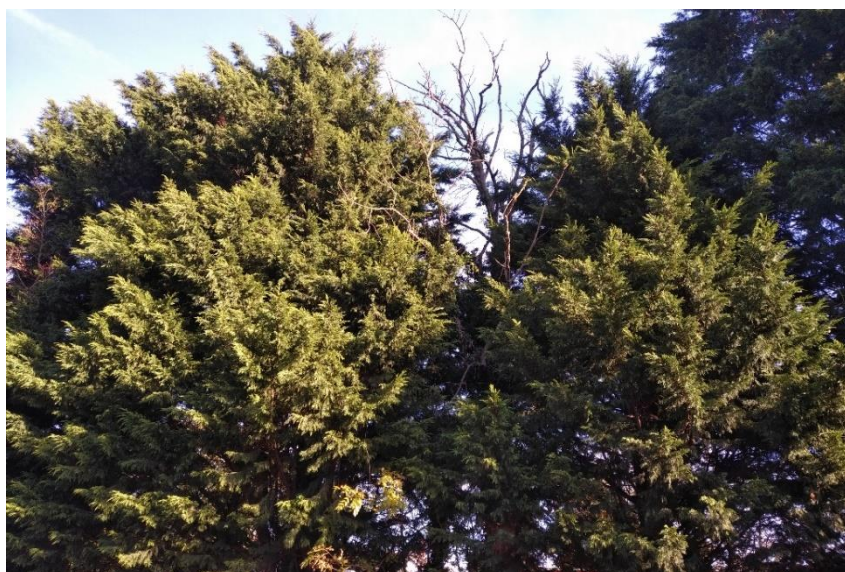
- 3.2.1 The common lime (*Tilia x europaea*) tree T15 on the eastern boundary was observed to be in a poor condition and in decline in the tree survey reported in the previous Arboricultural Report. At the current inspection it was observed that it had declined further in condition and over 95% of the crown was dead. There was no access to the base of the tree due to a fence, and the view of it was obstructed by the line of cypress trees. The tree appears to be in irreversible decline and it is almost certain that it will die over the next 1-5 years. The tree is located adjacent to the busy A16 Spalding Road and should be felled as soon as possible. The tree is not covered by TPO.

Image 6. Dying lime tree T15.

- 4.2.1 The dying lime tree T15 should be felled as soon as possible.

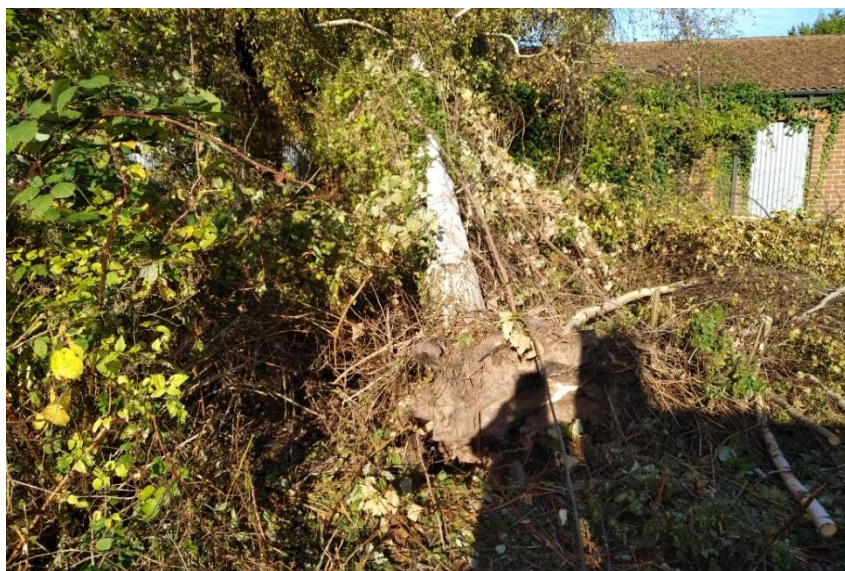
- 3.3.1 The silver birch (*Betula pendula*) tree T26 was proposed for retention in the previous Arboricultural Report, but was observed to have been uprooted and fallen at the current inspection. The root plate was inspected and root decay was observed. This will have been the main contributor to the windthrow of the tree in recent autumn winds.

Image 7. Windthrown birch tree T26.

- 4.3.1 The fallen birch tree T26 should be removed.

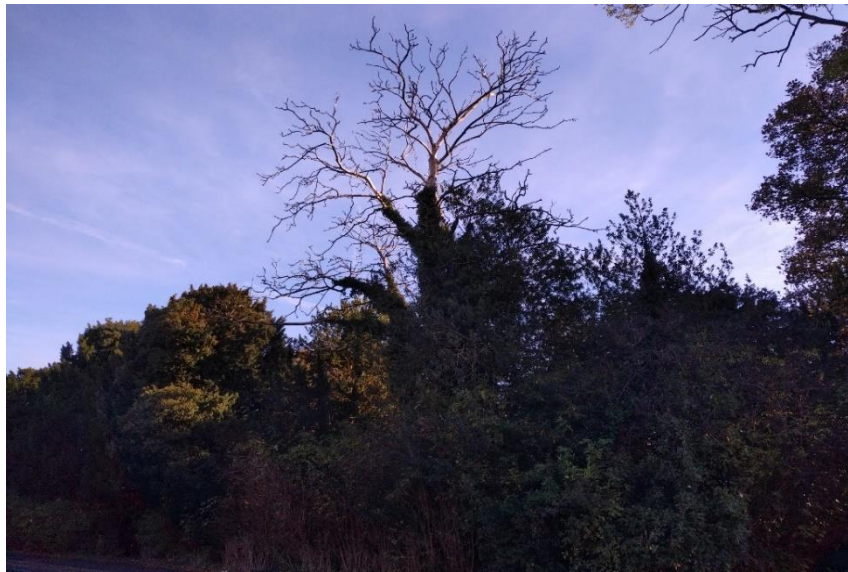
- 3.4.1 The sycamore tree (*Acer pseudoplatanus*) T49 is dead, as identified in the previous Arboricultural Report. The tree is located adjacent to London Road and should be felled as soon as possible as it represents a potential risk to road users.
- 3.4.2 The tree is covered by TPO. Permission is not required to fell trees covered by TPO where they are dead, but landowners are encouraged to contact the local planning authority and provide five days written notice so the exemption can be agreed. The Council officer inspected the tree during the meeting and agreed that it was dead and could be felled under his exemption.

Image 8. Dead sycamore tree T49.

- 4.4.1 The dead sycamore tree T49 should be felled as soon as possible. The LPA should be provided with five days written notice of the work as the tree is protected by TPO.

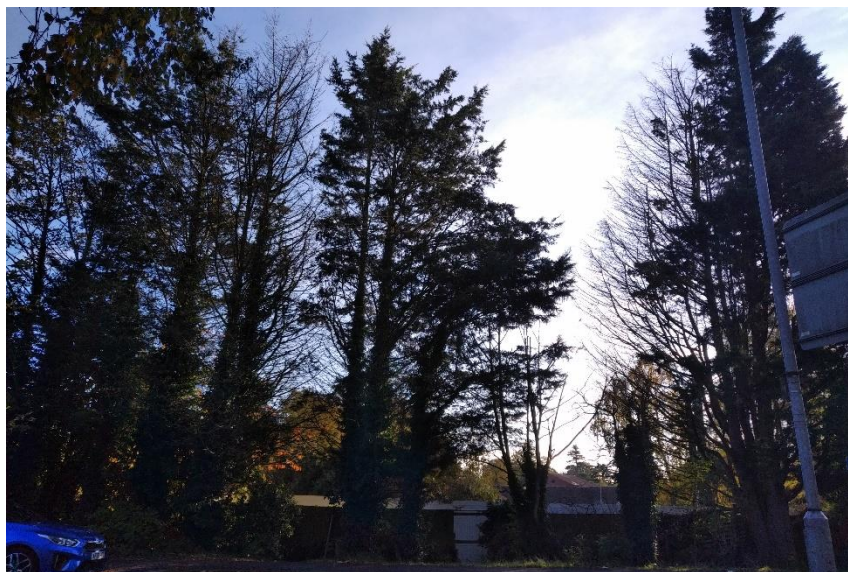
- 3.5.1 The previous Arboricultural Report identified several dead and dying trees in the row of Leyland cypress trees (*x Cupressocyparis leylandii*) along the northern boundary with London Road (group G3), and proposed their felling. The current inspection identified three dead cypress trees and five cypress trees in poor condition. These represent all the cypress trees in this group. The trees in poor condition have suffered significant crown thinning and dieback. The tree appears to be in irreversible decline and it is very unlikely that they will recover. They should be removed.

Image 9. Dead and dying Leyland cypress trees in group G3.

- 4.5.1 All eight dead and dying Leyland cypress trees in group G3 should be felled. The broadleaved trees within the group should be retained.

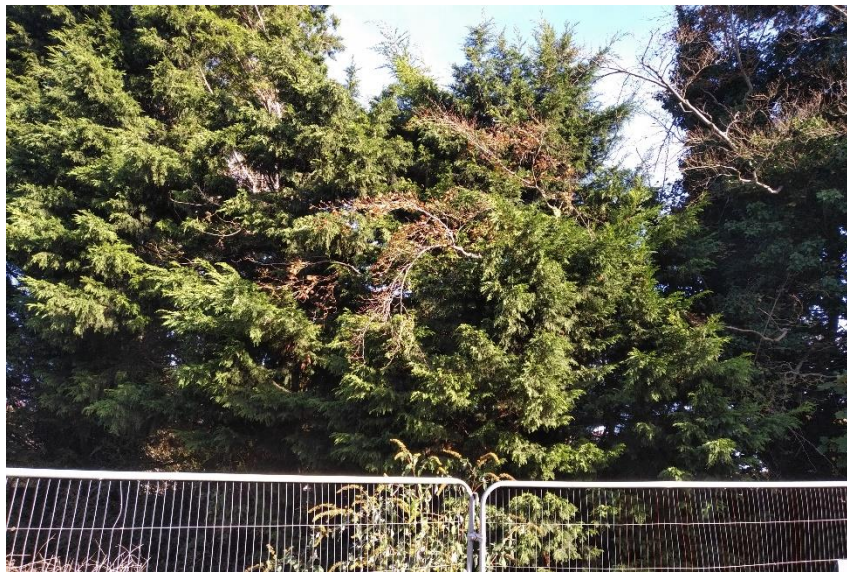
- 3.6.1 The previous Arboricultural Report identified several collapsed trees in the row of Leyland cypress trees along the eastern boundary with Spalding Road (group G5), and proposed their felling. The current inspection identified two collapsed trees are present to the north of the lime tree T15. These trees have collapsed due to splitting at weak forks. The trees will not recover to form attractive stable trees and should be removed.
- 3.6.2 A beech (*Fagus sylvatica*) tree is growing nearby in the row of trees, but is suppressed by the cypress and ivy growth. Removal of the failed cypress and ivy would allow the tree to flourish.

Image 10. Beech tree growing among failed Leyland cypress trees in group G5.

- 4.6.1 The two collapsed Leyland cypress trees in group G5, located to the north of tree T15 should be felled.
- 4.6.2 Ivy growing on the beech tree adjacent to the felled trees should be cut at the base of the tree, removing sections of one inch from each ivy stem to kill the growth above in the crown.
