Tree Report, Oak tree, 59 Garfits Lane, West Skirbeck

22 November 2023

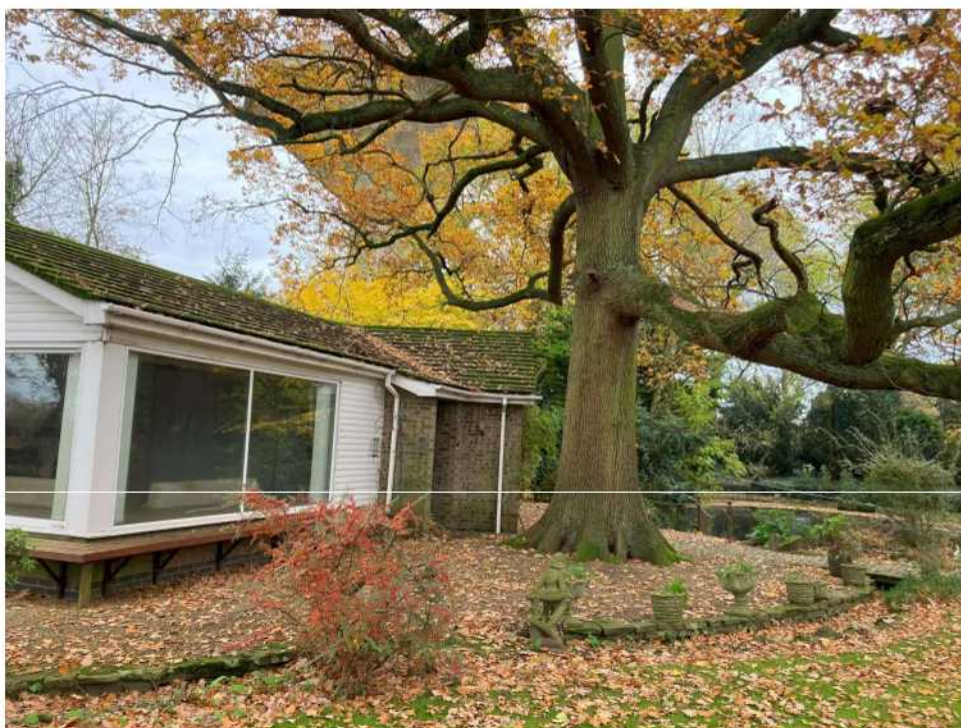
Oak tree

The tree concerned is a pedunculate oak, 22m tall, 115cm stem diameter at breast height with a crown spread of 15m. The base of the tree is only 1.5m from the bungalow and the crown extends entirely across the roof with a large branch down 50cm above the roof. The tree stands to the south of the bungalow and the majority of weight in the crown including the larger branches are on the south side. The crown of the tree is healthy with only minor deadwood, the result of natural suppression of lower branches. The tree was inspected for signs of disease or decay and none were found. The stem was tapped with a sounding hammer and sounded solid.

The oak tree is a fine specimen tree with a life expectancy of many decades or even centuries and is worthy of continued protection.

If the tree were to fall on the bungalow the consequences are likely to be catastrophic, hence this report, but the tree shows no sign of structural faults. The weight of the crown and the prevailing wind make any structural failure of the tree likely to fall away from the bungalow.

Remove any deadwood thicker than 4cm from the crown of the tree (this does not require consent under the TPO).

Prune the limb of the tree that is 50cm above the roof (20cm diameter) to the branch junction above the edge of the roof, to give 100cm clearance.

Remove branches less than 20cm diameter that are within 4m of the roof, to improve air flow over the roof. These last 2 recommendations will require TPO consent.

Have the tree inspected by a qualified arboriculturist every 2 years.
