PRELIMINARY STRUCTURAL REPORT
UPON
FORMER VILLAGE HALL
DAVID'S LANE
BENINGTON
LINCOLNSHIRE
PE22 0BZ

PRELIMINARY STRUCTURAL REPORT

FORMER VILLAGE HALL

Ref: 34121

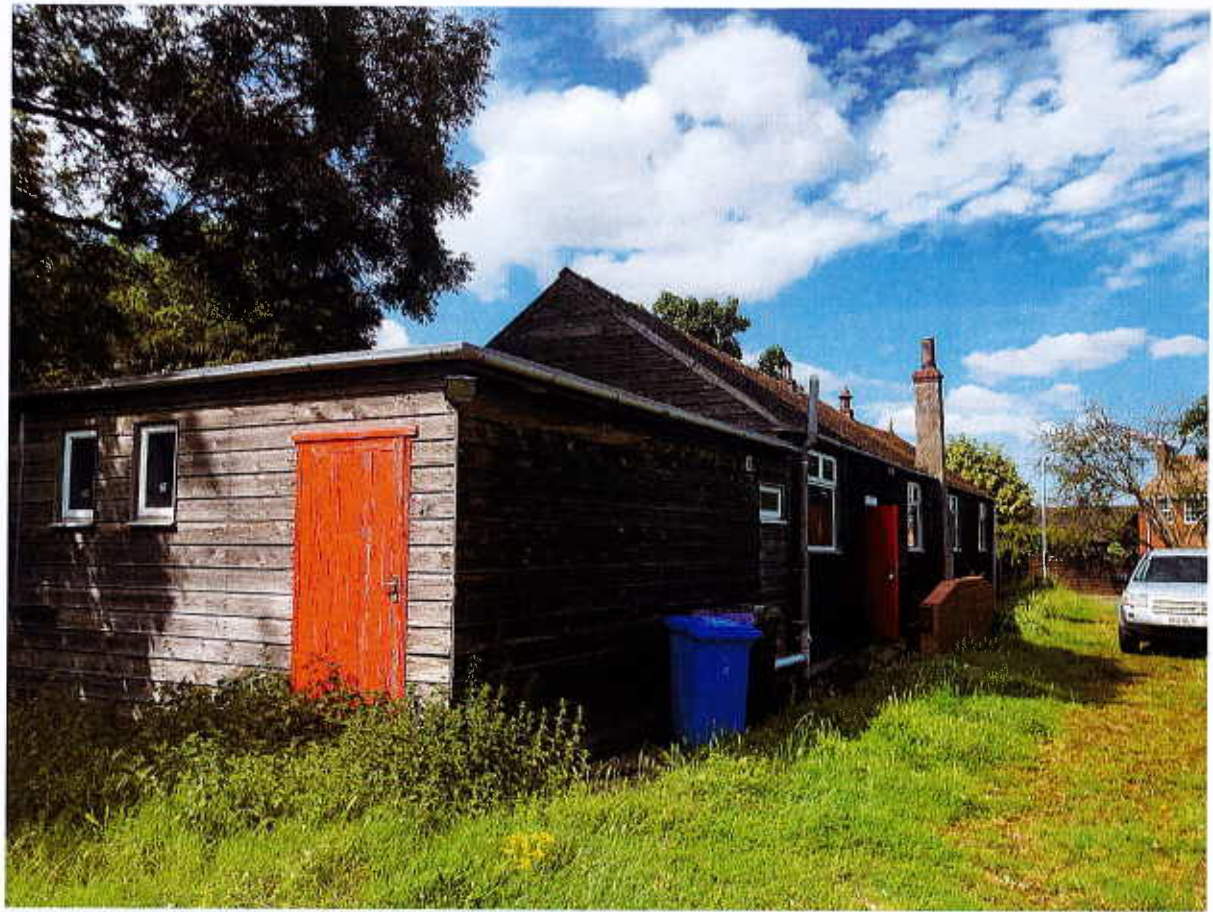
PHOTOGRAPH 1

When viewed externally, the rear flat roofed area appears to have been an extension to the original building, since the external timber cladding does not match the original pitched roof portion – see photograph 1.

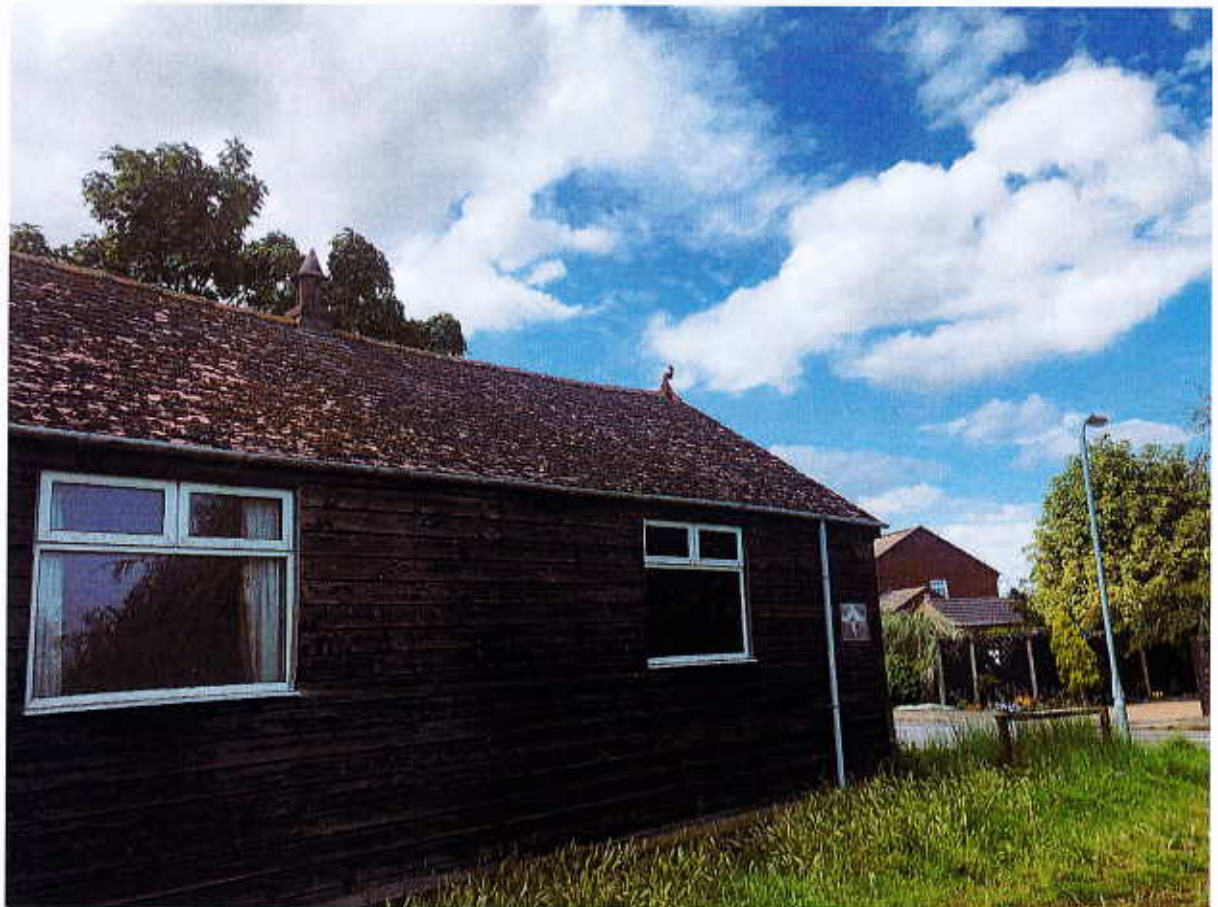
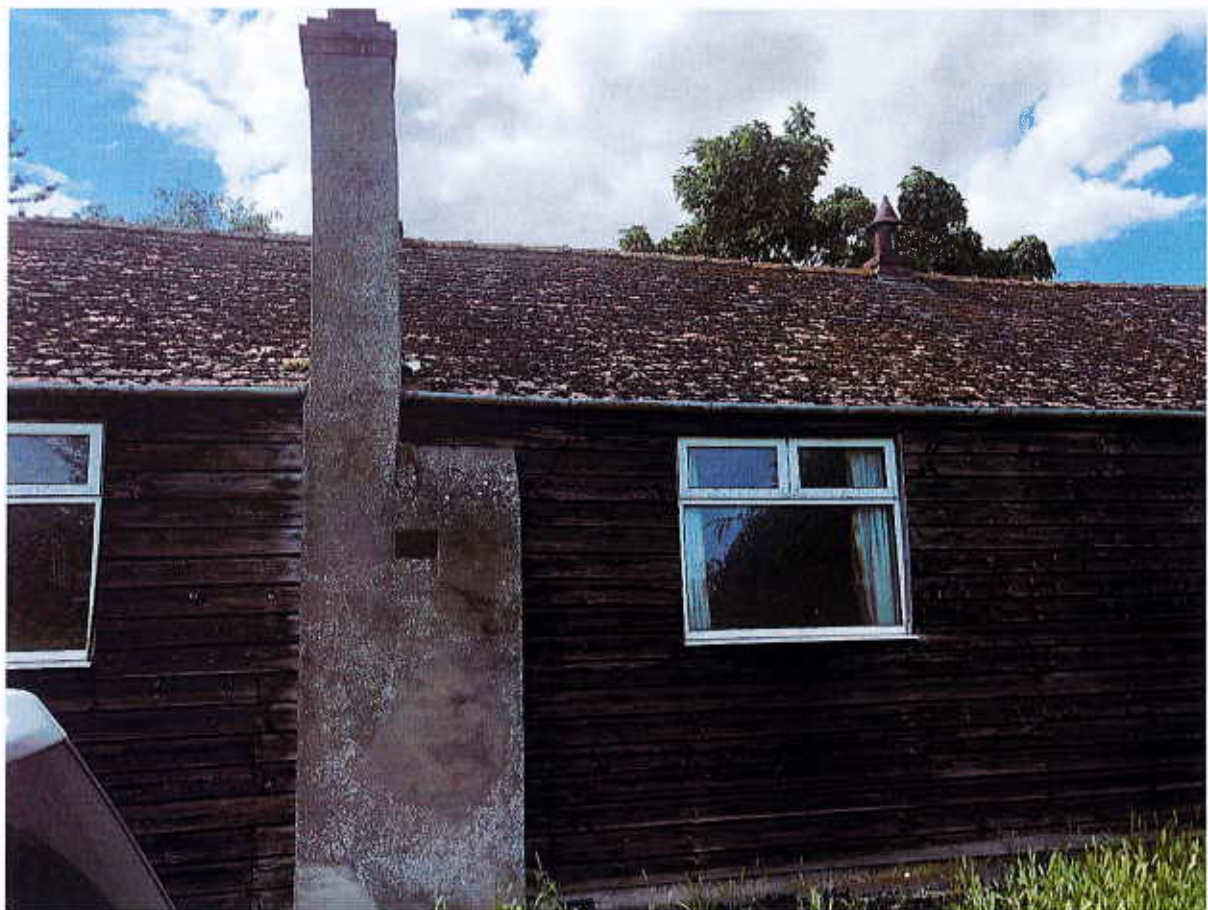
The apex line of the roof does undulate slightly throughout its length – see photographs 2 and 3.

When viewed along its length, the timber framing of the wall tends to lean outwards slightly at eaves level.

Whilst the timber roof frame above the tie is considered suitable, the horizontal tie at purlin level has been unable to resist the horizontal load generated, without allowing the external walls to lean outwards and the apex undulate.

With the roof structure to remain, all existing tie members must also remain, and introduce additional ties to ensure new and existing ties are present at every other rafter location.

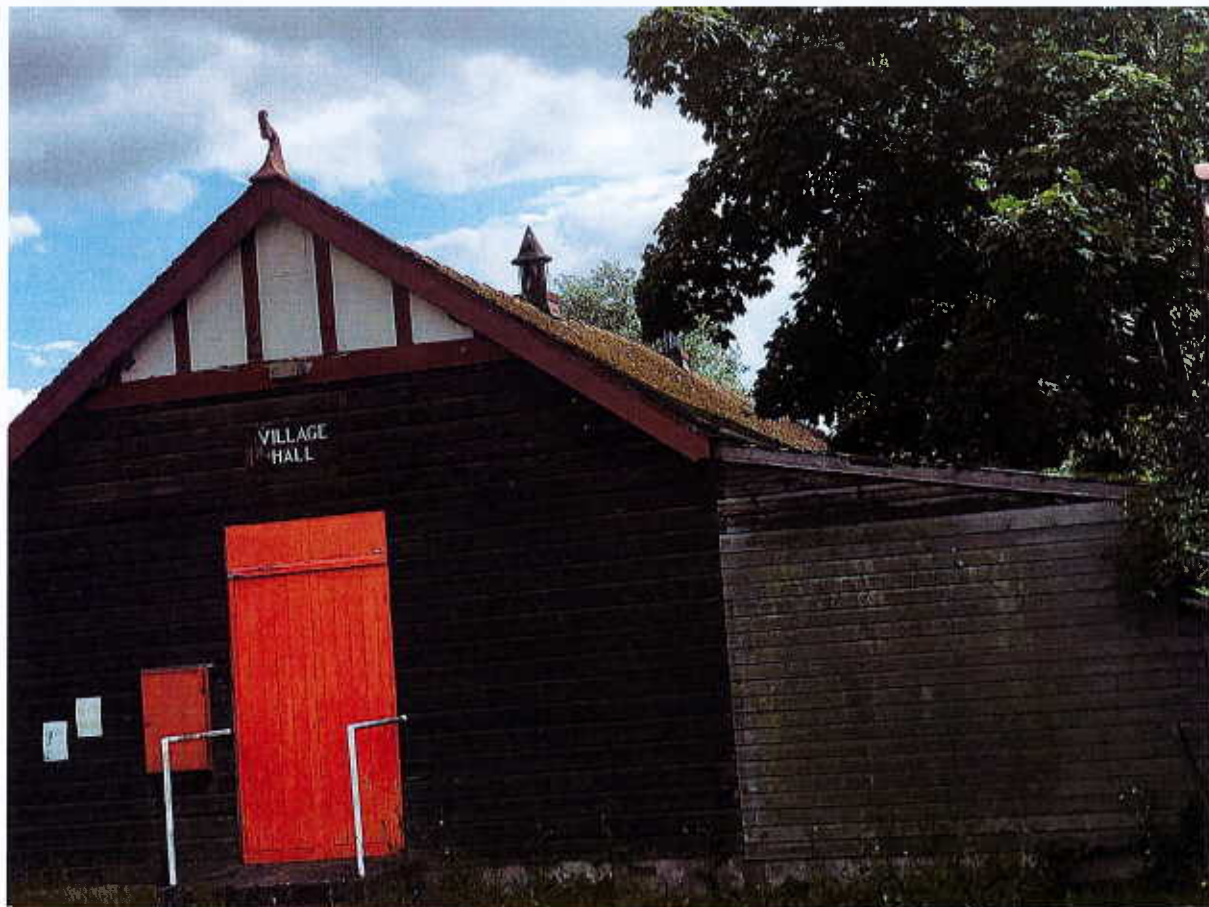
PHOTOGRAPH 4

The timber cladding extends within the front elevation, with a more recent extension having been added to the right hand side – see photograph 4.

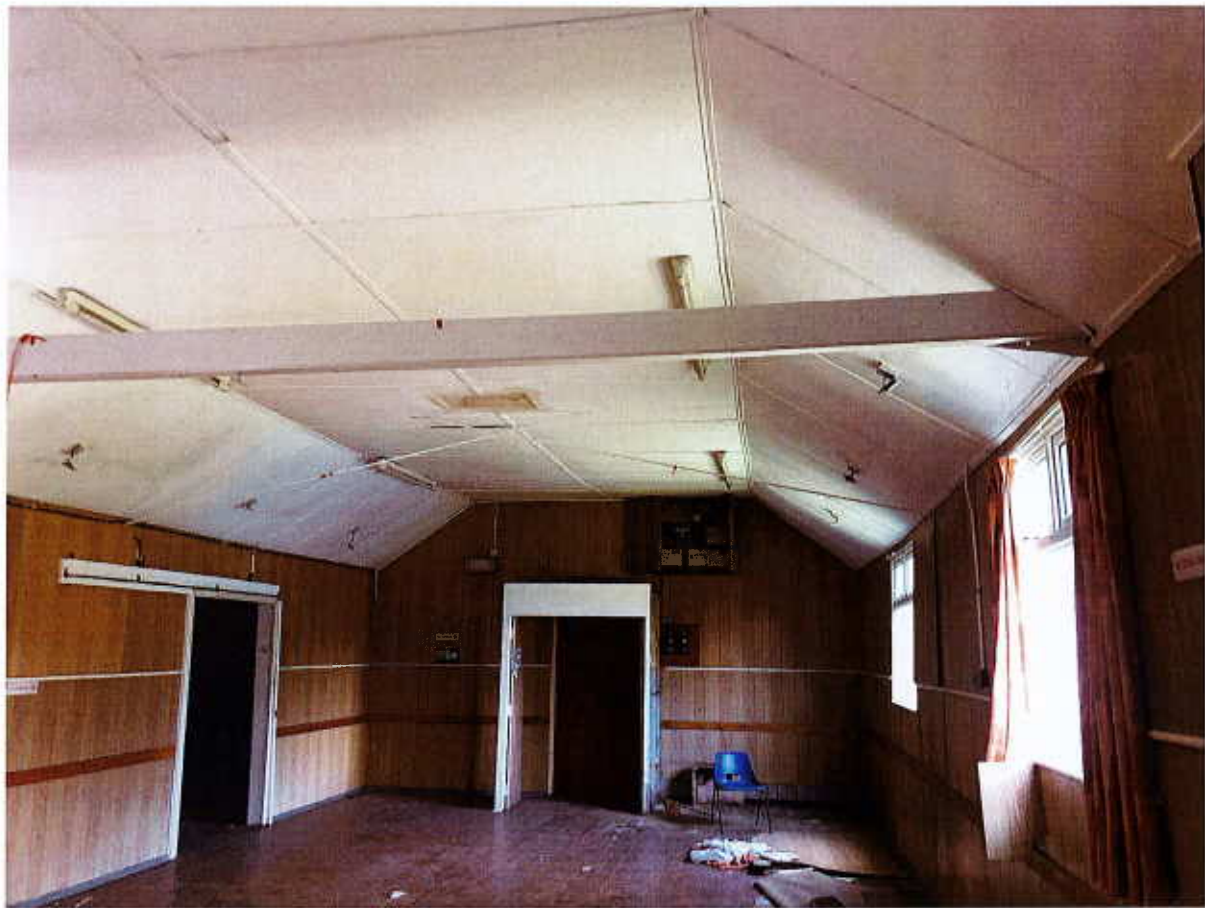
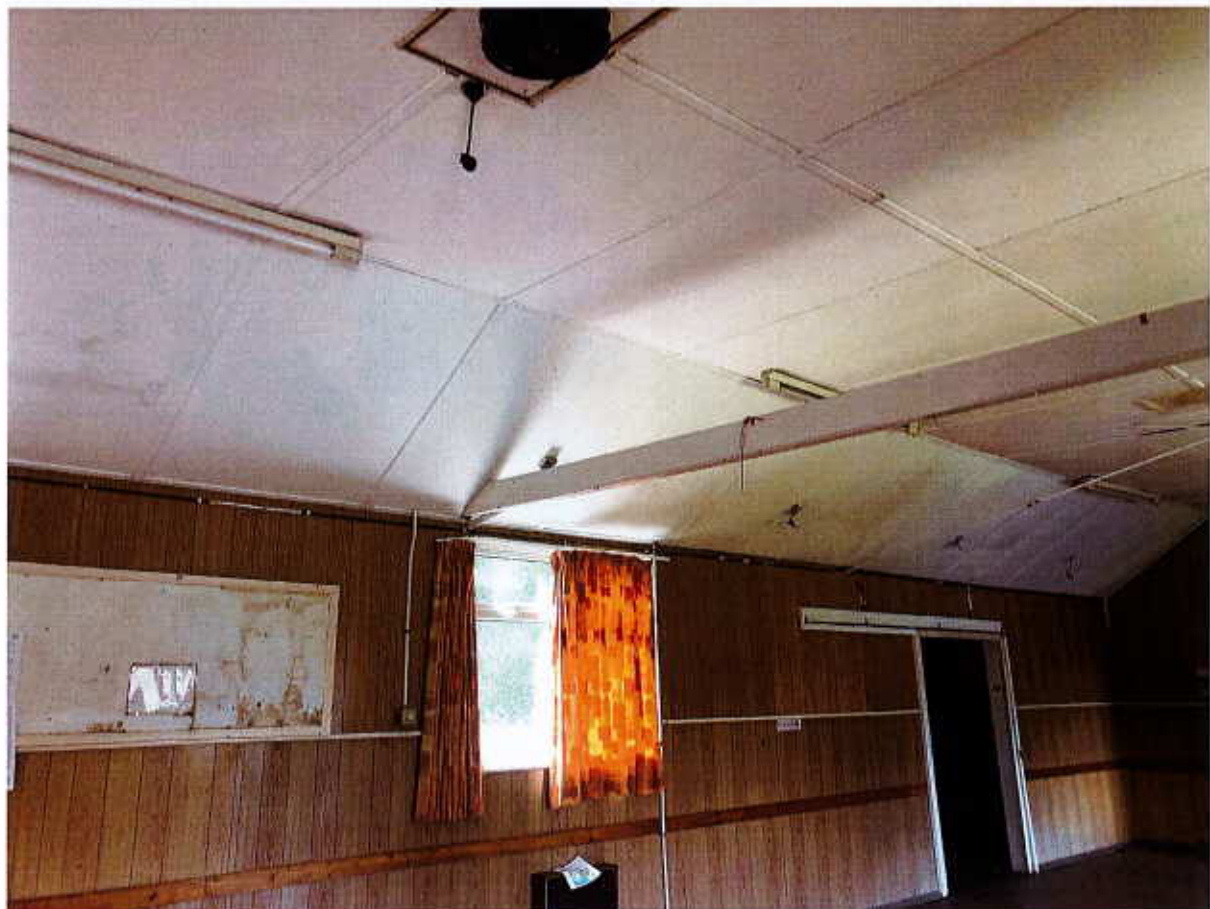
The roof structure has a raised tie, with both diagonal steel tie bars and a horizontal timber tie present at eaves level – see photographs 5 and 6.

It is likely the present ties at eaves level were introduced soon after construction, to arrest further horizontal movement.

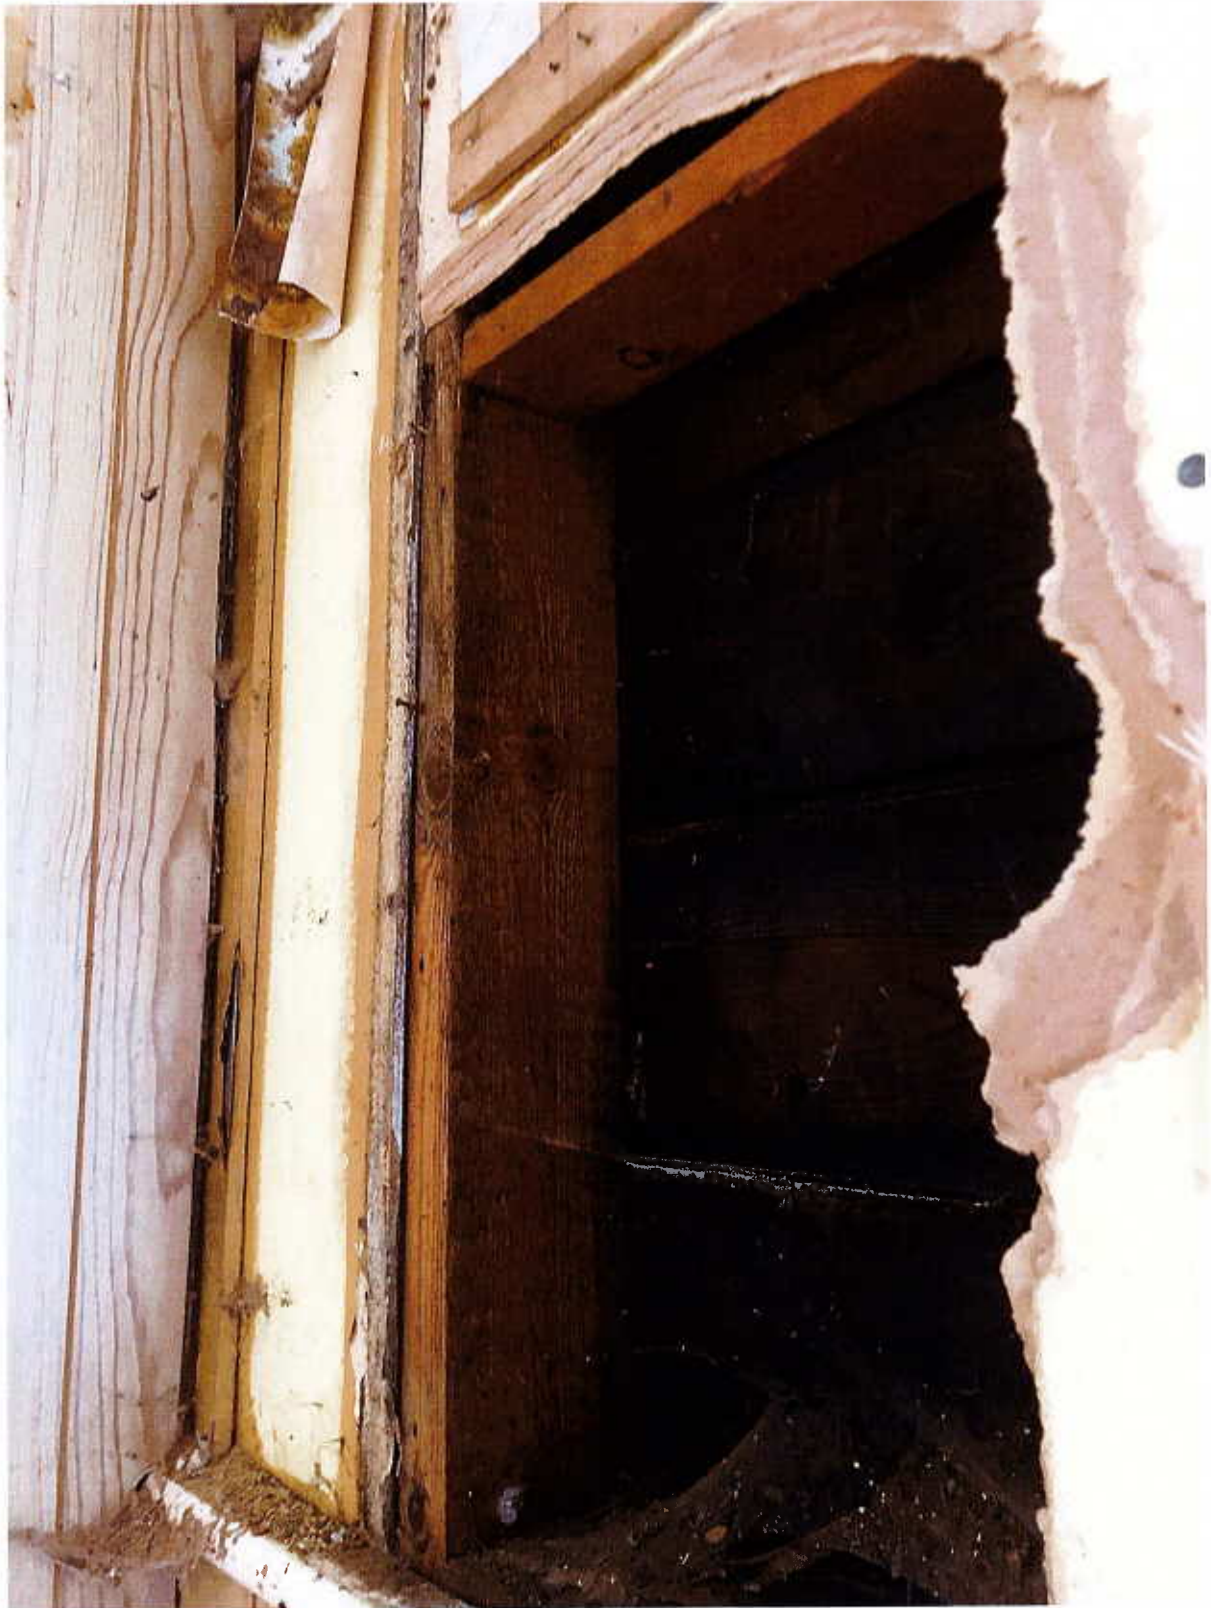
PHOTOGRAPH 7

An area of the internal wall surface had been removed, to reveal vertical 100 x 50 timber posts at 400 centres forming the wall structure – see photograph 7.

Assuming the wall timbers are not decayed, they can also remain.

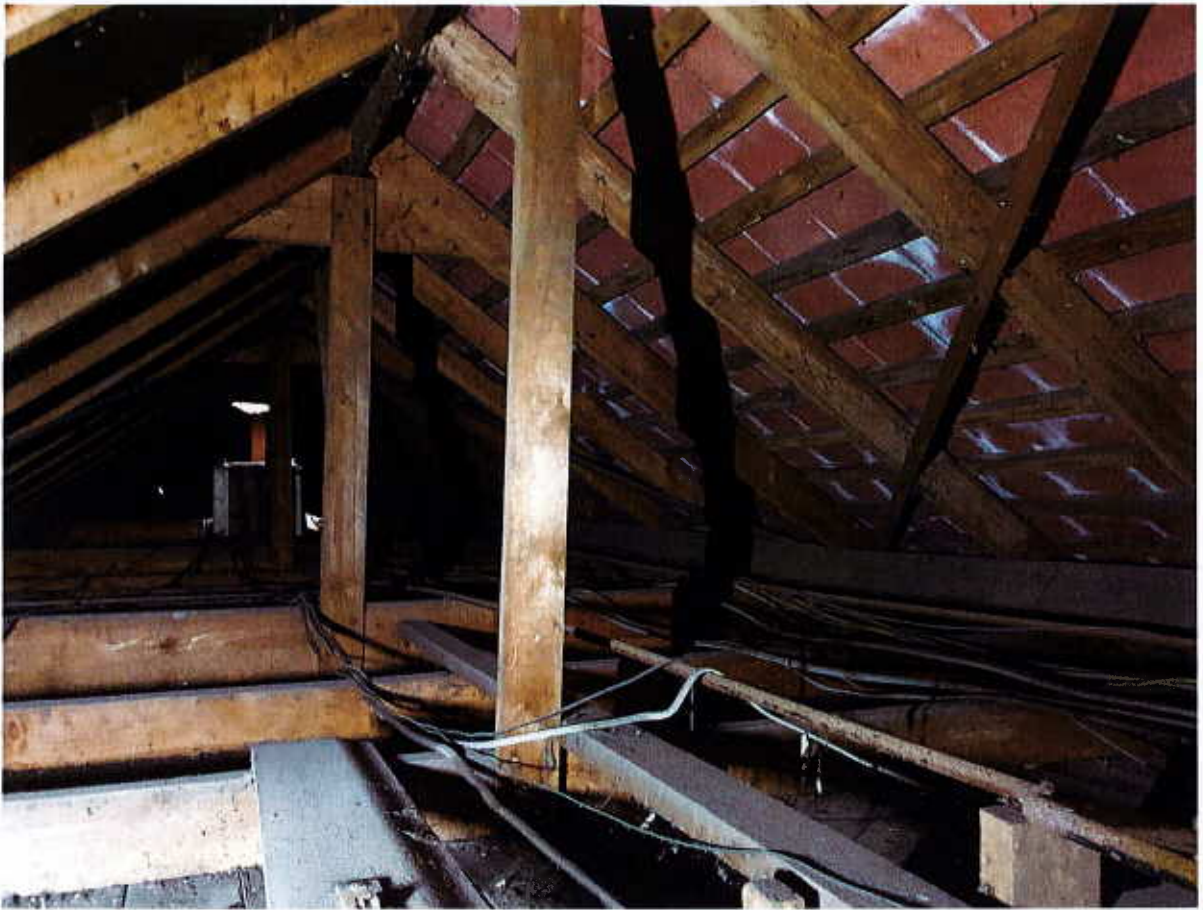
PHOTOGRAPH 8

Within the roof void of the pitched roof area the timber roof framing is relatively robust, with what appears to be adequately sized rafters and a purlin that undulates slightly – see photograph 8.

No waterproof membrane is present below the tiles, nevertheless the roof appears dry with no significant areas of water ingress.

The existing roof tiles should be removed and cleaned to allow a new waterproof membrane to be installed. Existing tiles should be re-laid to ensure no additional load is placed on the roof, which also includes the covering to form the ceiling.
