Archer Ecology Ltd Britannia House Marshalls Yard Gainsborough Lincolnshire DN21 2NA

19th April 2022

# Protected Species Survey: Patterdale Farm, Cut End Rd, Fishtoft

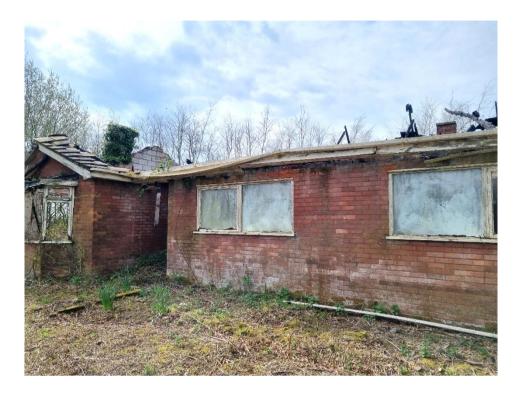
The redundant dwelling comprises a single-story, detached building constructed from a combination of breezeblock and brick walls (see Photograph 1, Appendix I). These support the remains of a single pitched

Photograph 1: Redundant dwelling viewed form eastern elevation

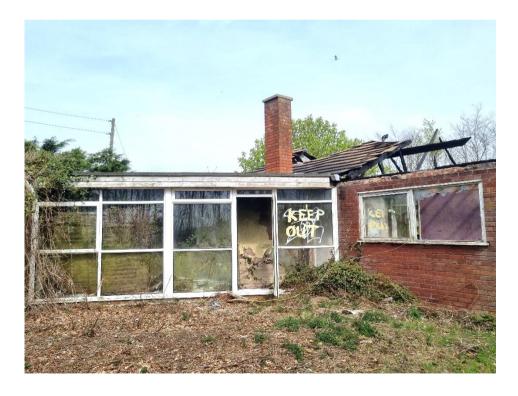
roof together with a flat, felted roof along an extension adjoining the western elevation, in addition to a single, intact chimney stack (see Photograph 2, Appendix I). The building features both wood framed and UPVC windows and doors across all elevations and an integrated garage along the northern aspect.

Photograph 2: Single storey dwelling and intact chimney stack

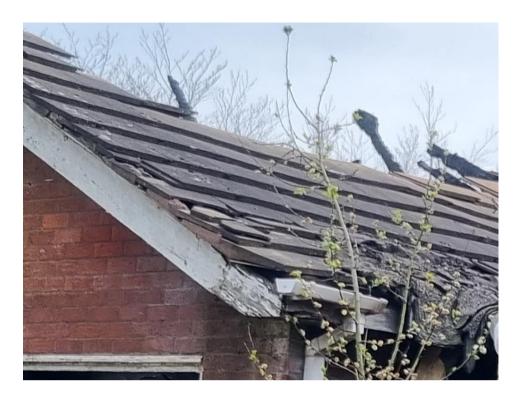
It is understood, through corresponding with the applicant, that the dwelling was subjected to a major fire incident in September 2017, resulting in severe damage and collapse of the former pitched roof. Any remaining sections of the roof are clad with interlocking concrete tiles (see Photograph 3, Appendix I). These are affixed directly onto the rafters with no separating membrane in between.

Photograph 3: Remaining section of dwelling roof with inter-locking concrete tiles

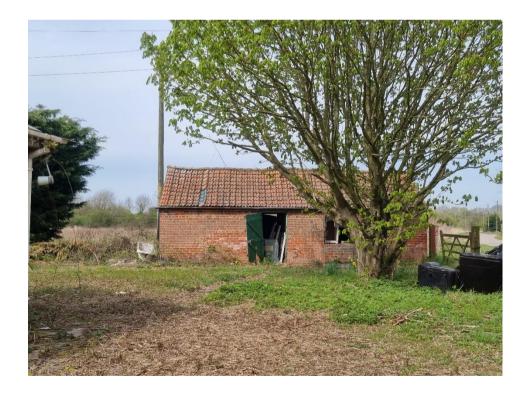
The detached garages comprise a small, detached and single-story building constructed from bricks and mortar (see Photograph 4, Appendix I). This supports a single-pitched, unlined, pantile clad roof with gable walls along the north-eastern and south-western elevations. The external brickwork of the dwelling was observed to be intact throughout with occasional spalling observed. However, no associated potential roosting features were noted. The roof was observed to be in reasonable condition and, with the exception of occasional lifted tiles (see Photograph 5, Appendix I), no inherent defects were recorded.

Photograph 4: Detached garage at northern extent of the application site

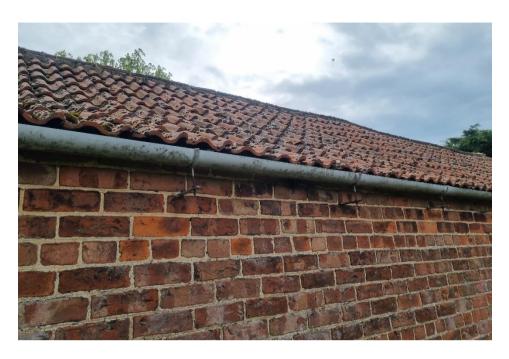
Photograph 5: Pantile roof viewed from northern elevation

- All contractors working on the building must be briefed on the legal protection afforded to bats and their identification.
- Works to the roof of the garages should be undertaken in a slow and controlled manner. Each roof
  tile should be carefully lifted and meticulously checked underneath for any evidence of bats
  (including live/dead bats, droppings and urine staining) before being carefully removed/discarded.

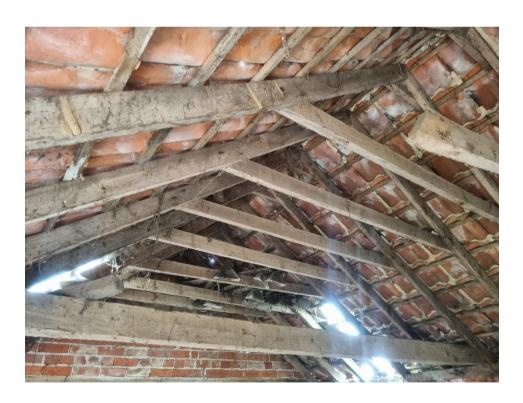
Observations of the interior of the garages indicated that the building is separated by a partitioning wall and is currently used for storage. The roof features skylights which have subjected the interior of the building to high levels of ambient light (see Photograph 6, Appendix I), contributing to sub-optimal conditions for roosting activity.

Photograph 6: Underside of pantile roof viewed from interior
