# Remediation Strategy

**Holland House Farm, Kirton Drove**

Delta-Simons Project No. 19-0923.03

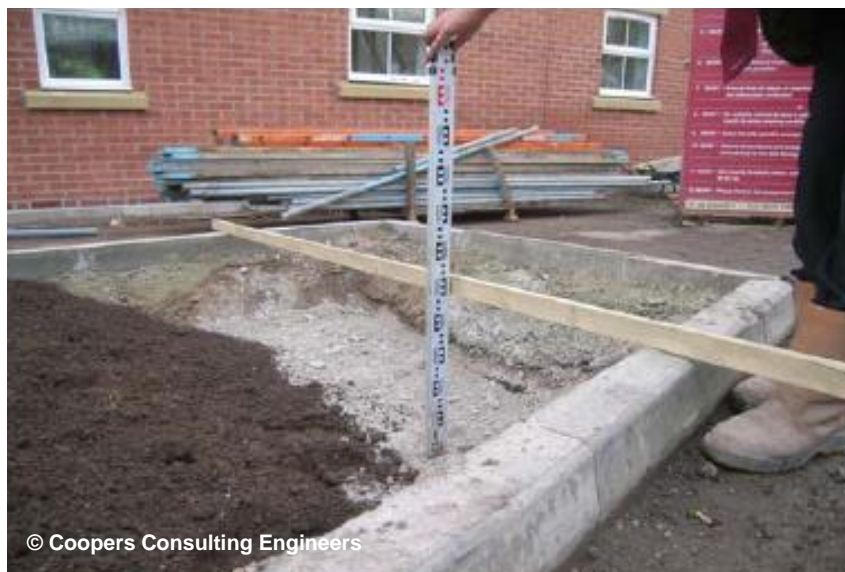
Photograph 1: Depth check of inert cover within area of public open space. Physical break layer and topsoil visible.

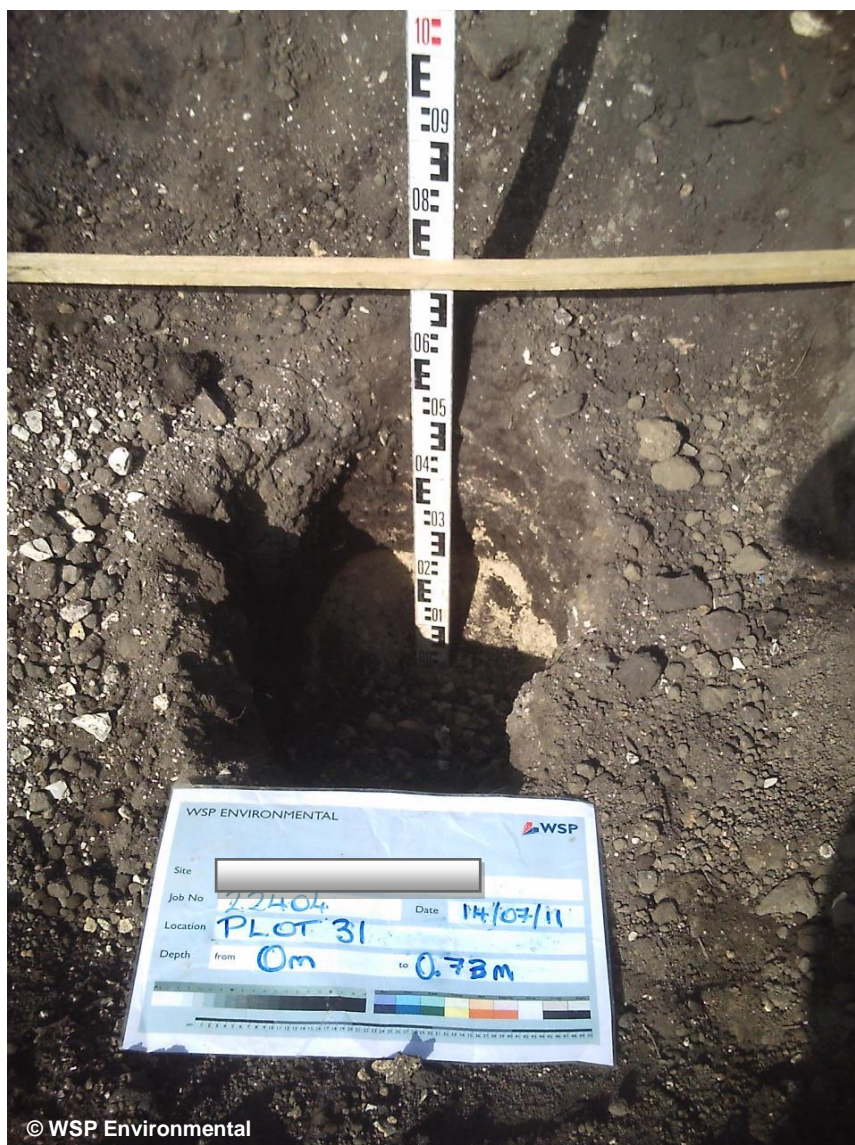
Photograph 2: Depth check of inert cover with Site & Location Information Board.

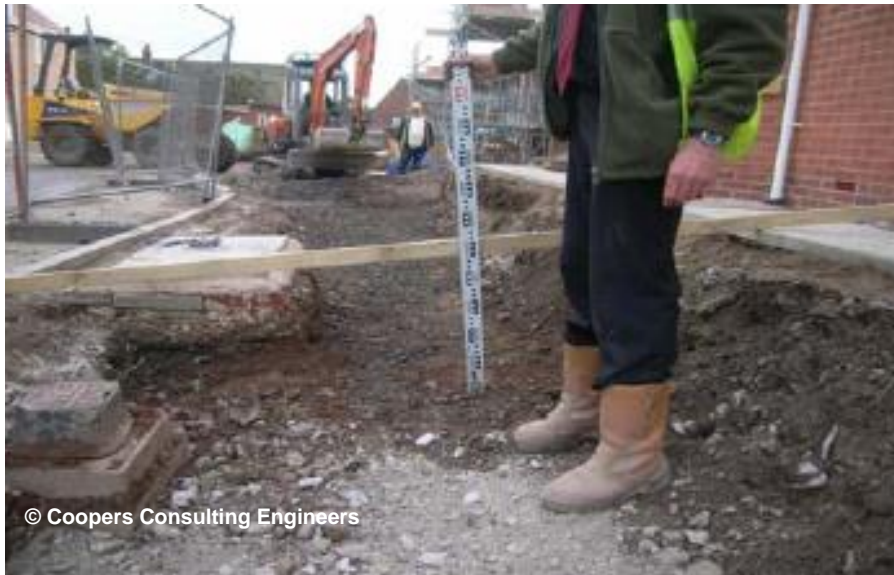
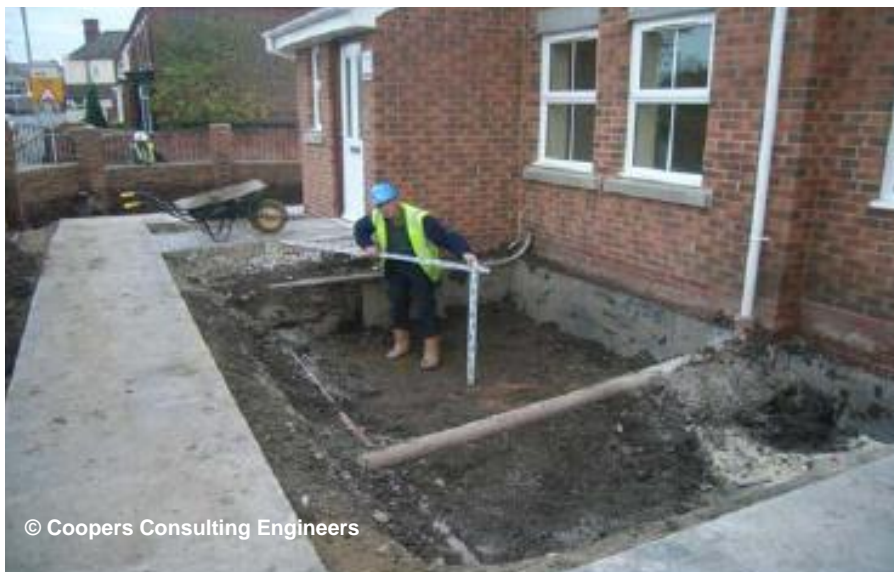
Photographs 3 & 4:  
Depth check of inert  
cover within areas of  
front gardens.

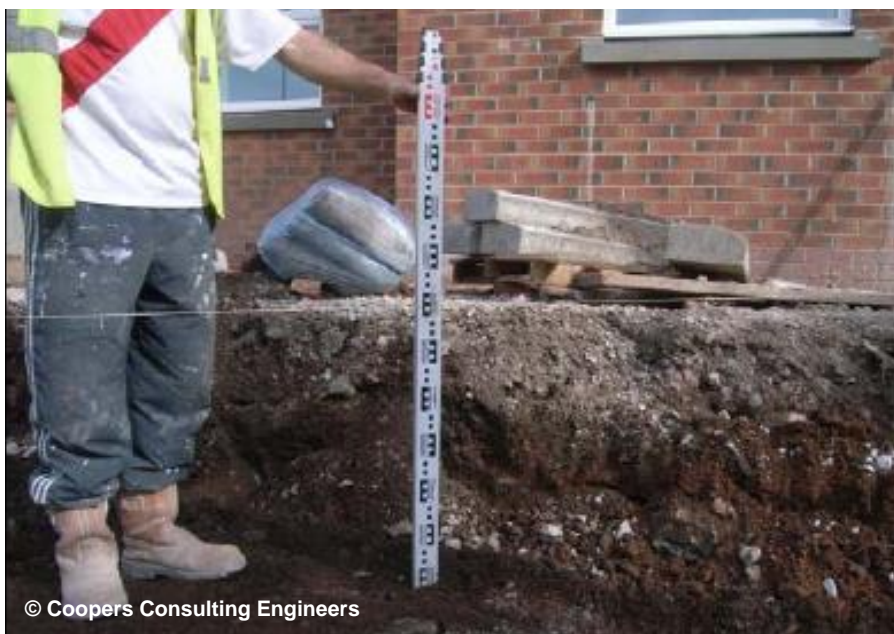
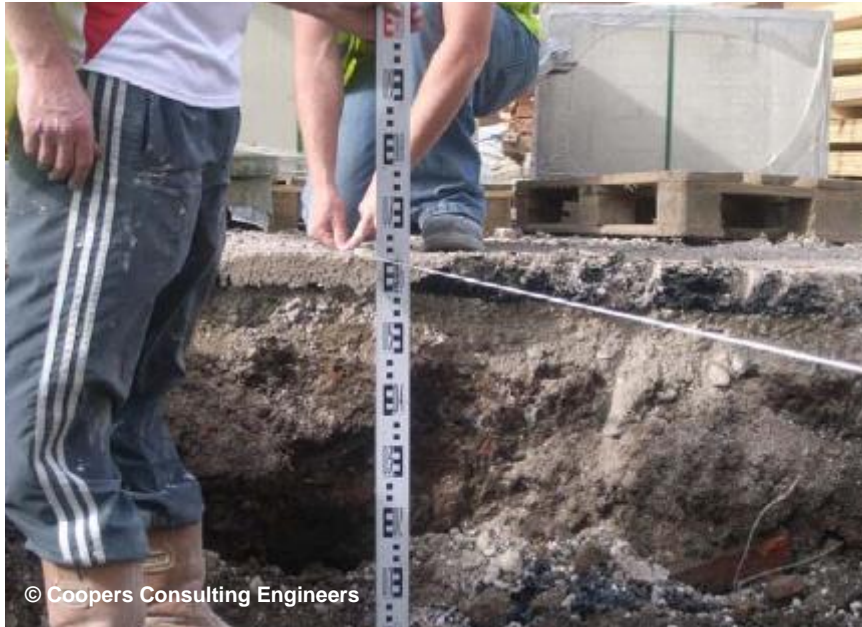
Photographs 5 and 6: Depth check of inert cover within rear gardens. Taut string line spans across excavation.

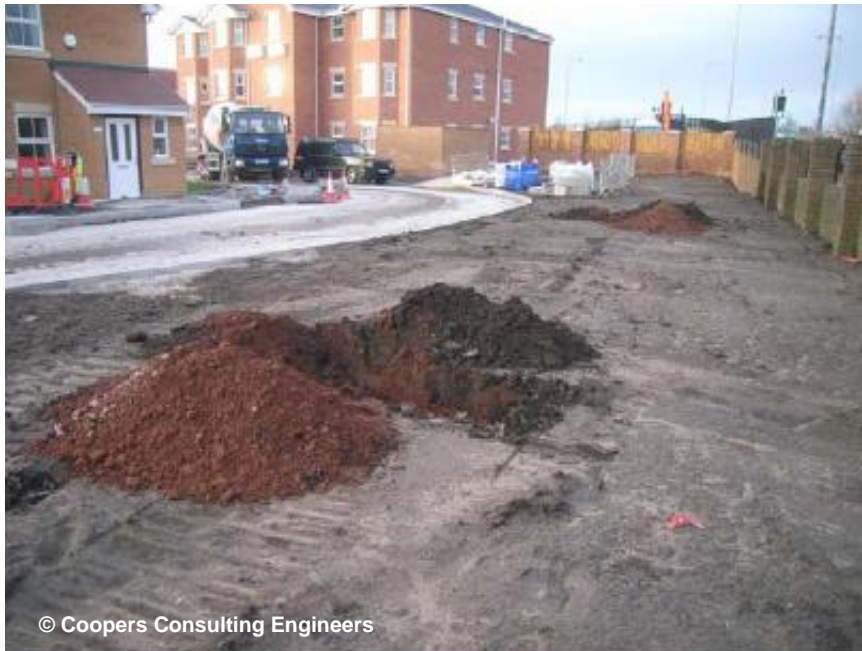
Photograph 7 shows the spatial location of the verification pit.

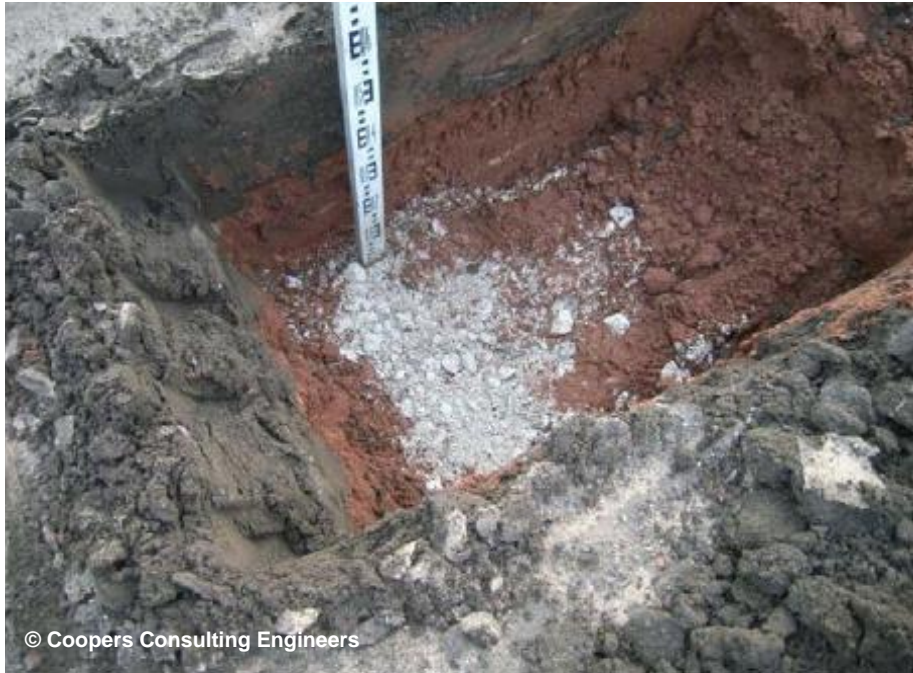
Photograph 8:  
Excavation within public open space and verification pit showing the presence of a remediation break layer at the base, a crushed sandstone inert fill overlain by topsoil.

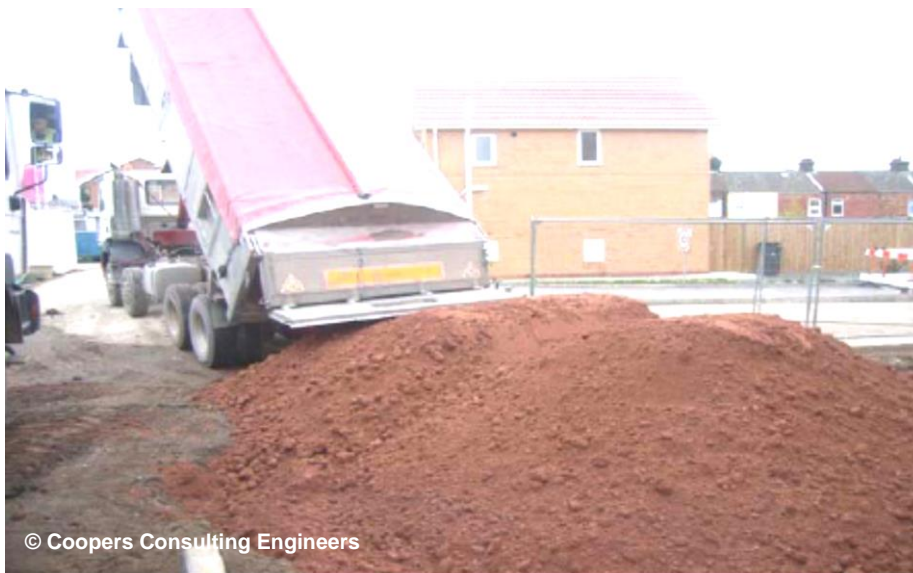
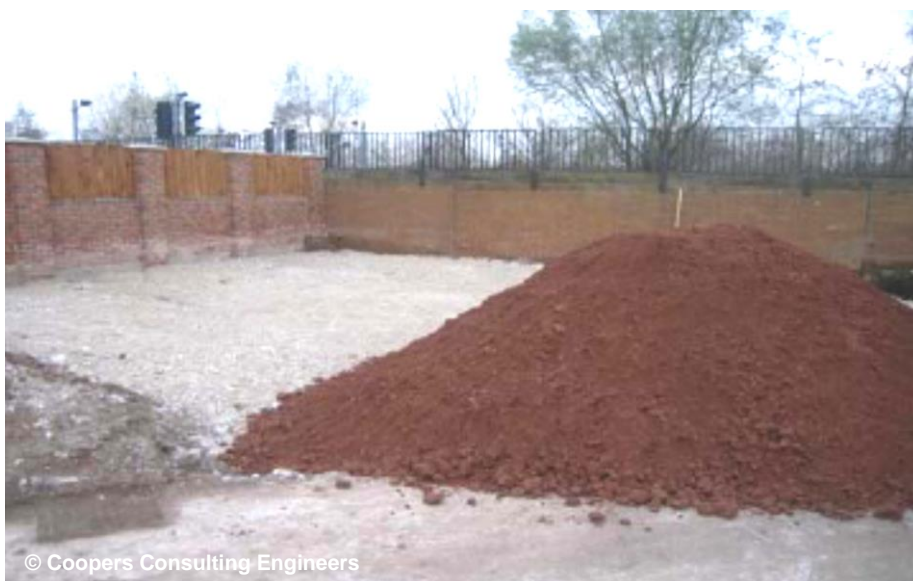
Photographs 9 and 10: Inert crushed sandstone being delivered with remediation break layer visible in Photograph 10. The spatial area of the remediation can be observed from these photographs (old terrace housing in Photograph 9 and traffic lights in photograph 10).

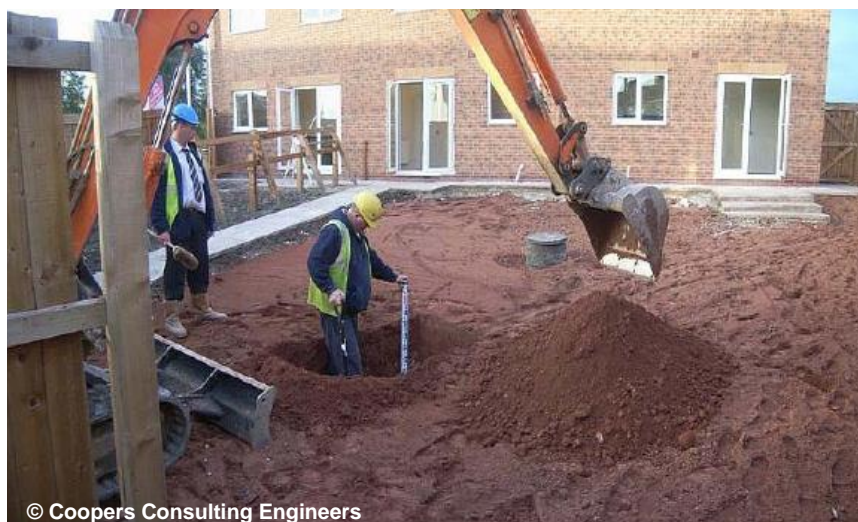
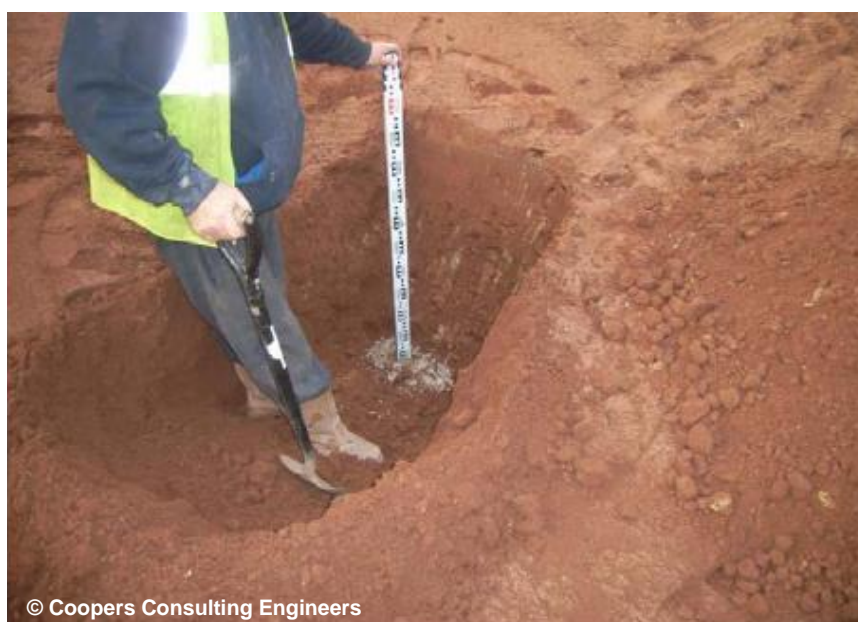
Photographs 11 and 12 show the remediation of the rear garden, with a significant depth (1.0m) of inert cover. Remediation break layer visible at the base of the excavation. Photograph 11 has been stitched to form a panoramic photograph and
