**ECOLOGY AND PROTECTED SPECIES SURVEY**

**BUILDING AT CRAYTHORNE LANE, BOSTON,  
LINCOLNSHIRE.**

**November 2019**

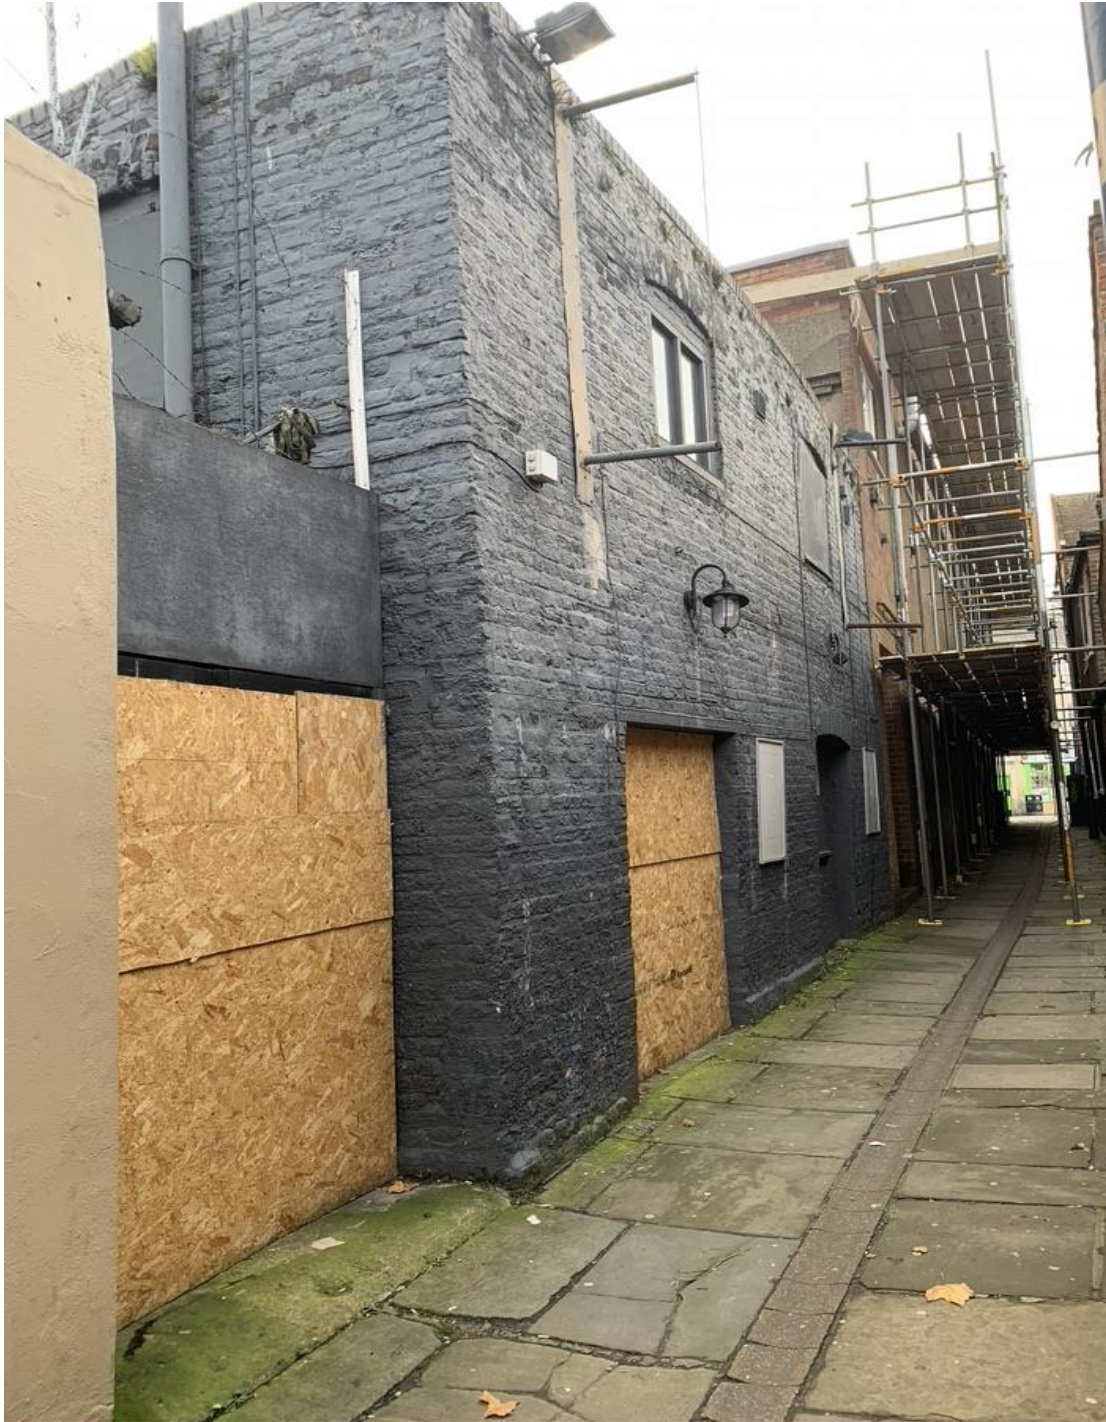
**Photo 1: Eastern elevation of the building**

A three-storey building, rectangle shape on plan, constructed of solid brick walls supporting a pitched roof covered with bitumen felt and pan tiles and also some flat roofed areas. There are tightly fitted glass windows and roof lights on the second floor of the building resulting in high ambient light levels. The upper floor (third floor) has some open windows and missing glazing. The windows on the ground and first floor have been bricked up or boarded resulting in no natural light. There are small roof void areas which can be accessed off the third floor.

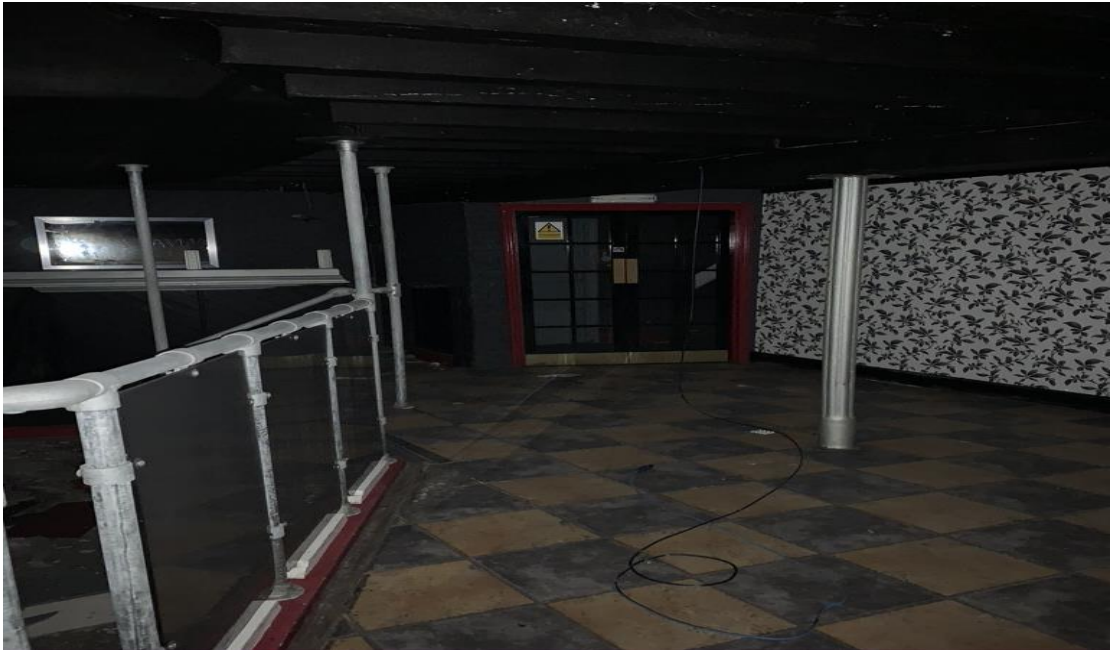
**Photograph 6: Further internal view of the building**

Inside the building is divided up into numerous seating areas, staircases, cupboards, bars, cloakrooms, dancefloors and restrooms. There are also steps leading down to a cellar.

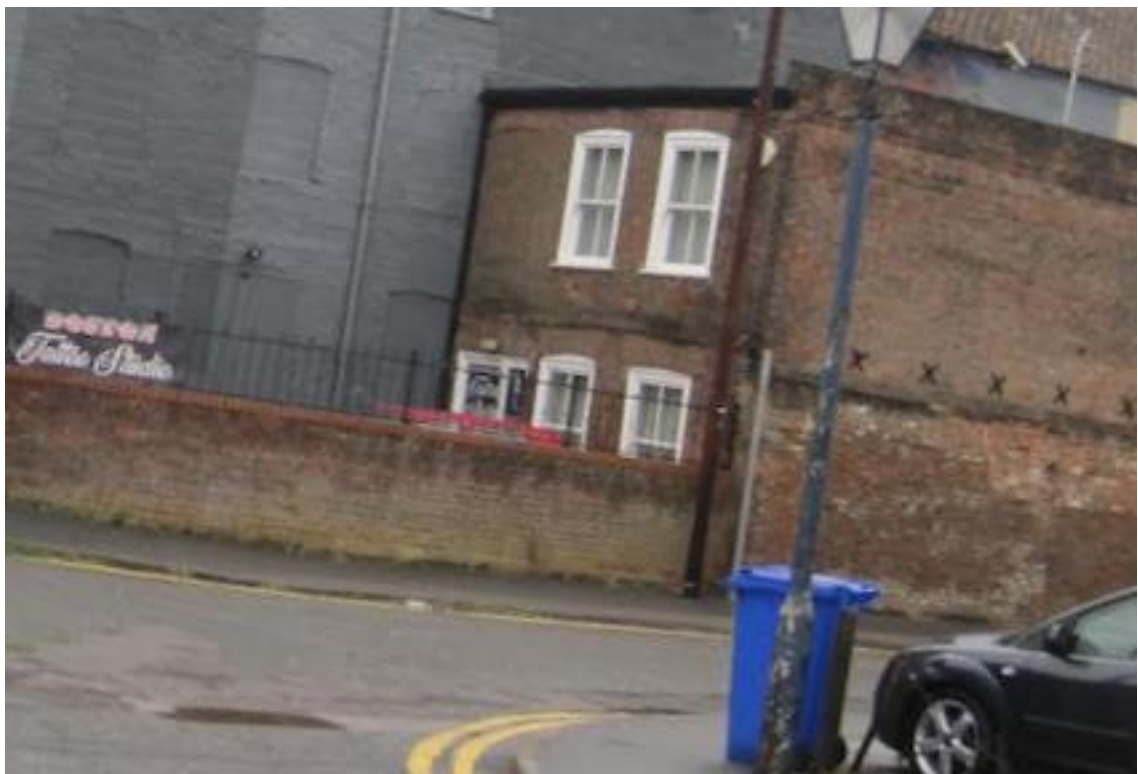
Boston Tattoo Studio forms part of the building on the south west side. Craythorne House (recently renovated into 3 family homes) is to the south of the building, Mr T's carpet shop to the east and Piranha nightclub to the west. The surrounding landscape is dominated by mainly shops and the busy A16 road.

**Photograph 12: Adjacent buildings – attached to the survey building**

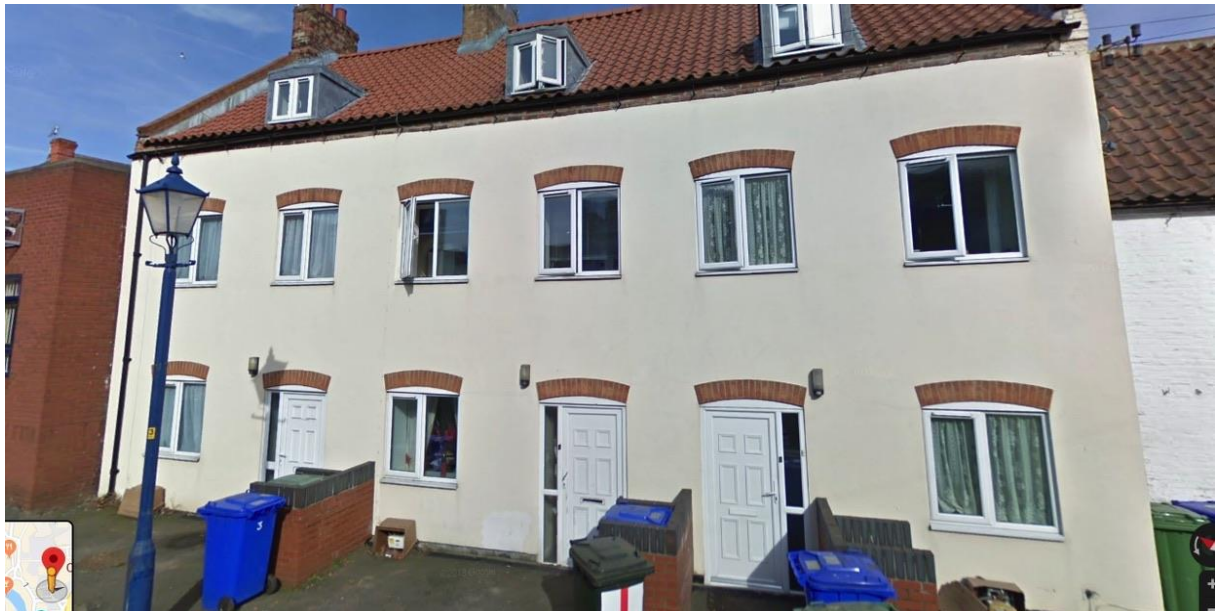
**Photograph 13: Adjacent residential dwellings**
