FLOOR TIMBER ROT
INVESTIGATION REPORT
&
REPAIR METHOD STATEMENT

SHODFRIARS HALL

SOUTH STREET
BOSTON, LINCOLNSHIRE

April 2023

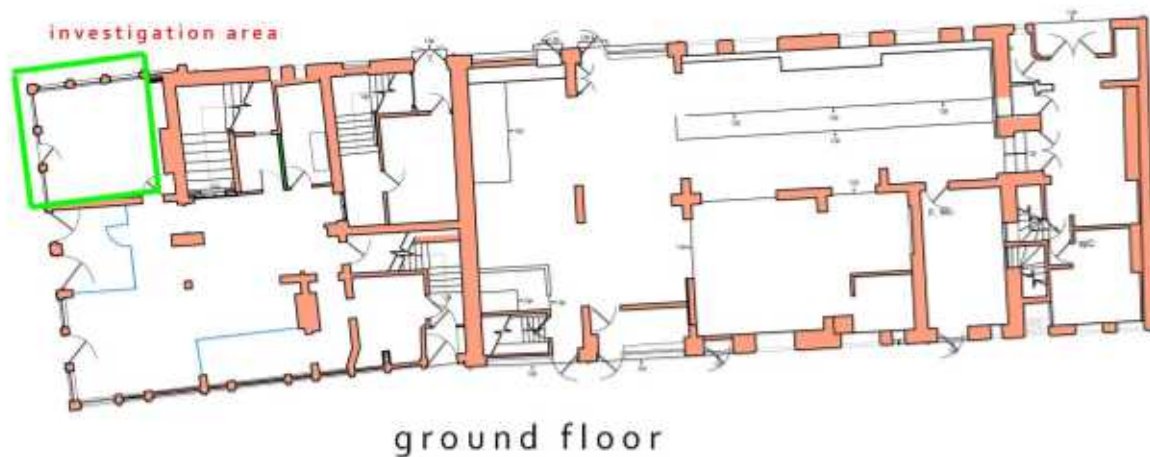
Figure 1 (top): the location of the investigation at the north-west corner of the building

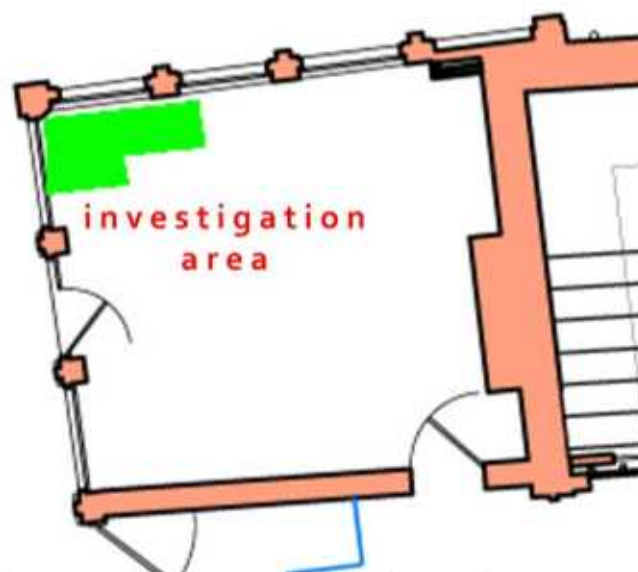
The area of the floor highlighted in the plans provided below was weak underfoot and had signs of rot in the plywood floor covering. Because the principal structure of this part of the building is oak frame of historic importance it was imperative to investigate the presence of fungal infestation and its extent.

Figure 2 (bottom): the exact location and size of the proposed investigation
