Tree Report, Oak tree, 59 Garfits Lane, West Skirbeck

22 November 2023

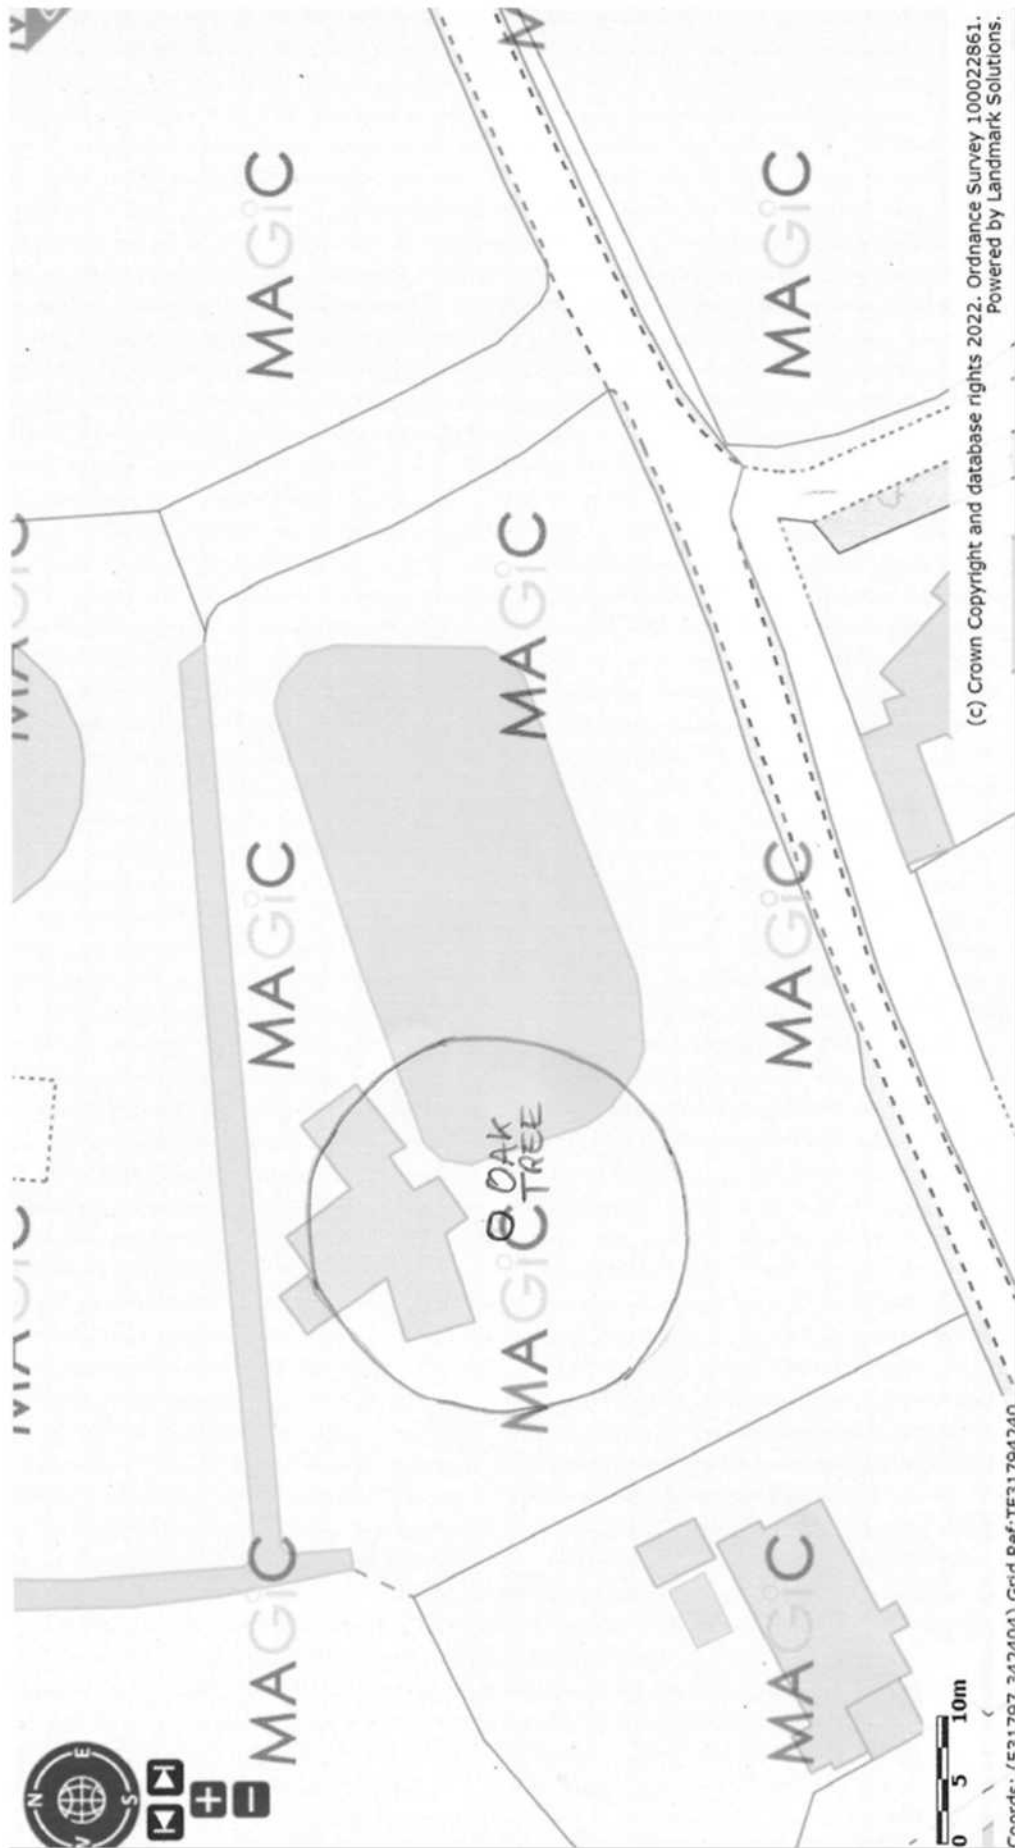
Oak tree

The tree concerned is a pedunculate oak, 22m tall, 115cm stem diameter at breast height with a crown spread of 15m. The base of the tree is only 1.5m from the bungalow and the crown extends entirely across the roof with a large branch down 50cm above the roof. The tree stands to the south of the bungalow and the majority of weight in the crown including the larger branches are on the south side. The crown of the tree is healthy with only minor deadwood, the result of natural suppression of lower branches. The tree was inspected for signs of disease or decay and none were found. The stem was tapped with a sounding hammer and sounded solid.

A large branch (40cm diameter) on the south side of the tree from 4m height appears to have dead bark on its top side but this is on the opposite side of the tree to the bungalow.

The bungalow was built in 1975 beneath the tree with the tree as a major feature, the crown of the tree overhanging the bungalow means that a lot of debris from the tree will fall on the roof and the shading makes the roof damp and mossy.

If the tree were to fall on the bungalow the consequences are likely to be catastrophic, hence this report, but the tree shows no sign of structural faults. The weight of the crown and the prevailing wind make any structural failure of the tree likely to fall away from the bungalow.

Remove branches less than 20cm diameter that are within 4m of the roof, to improve air flow over the roof. These last 2 recommendations will require TPO consent.
