GROUND CONTAMINATION INVESTIGATION AND ASSESSMENT PHASE 1 - DESK STUDY

for the proposed
Residential development
at

**Tattershall Road,
Boston
PE21 9LP**

Phase 1 Desk Study

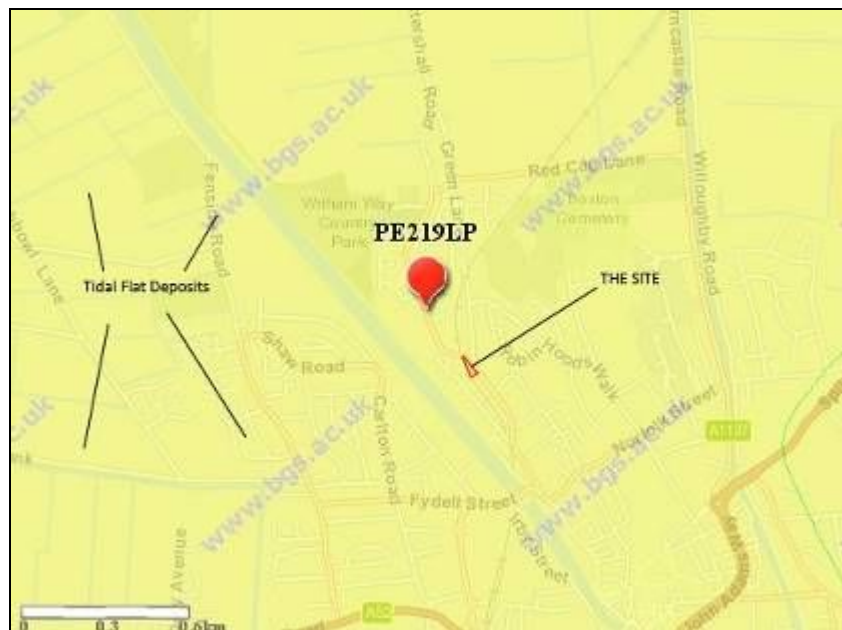
Fig 10 - Geology of the site

The glacial surface slopes gently eastwards, from 5 to 10-15 m below OD, contrasting with a much steeper slope on the west margin where the till surface rises to ground level, forming the Middle Marsh. The sharp rise suggests a wave-cut platform, although a valley has been suggested on the till surface leading towards Saltfleet, implying that there was a period when the till was exposed for long enough for surface drainage to become established before full inundation.

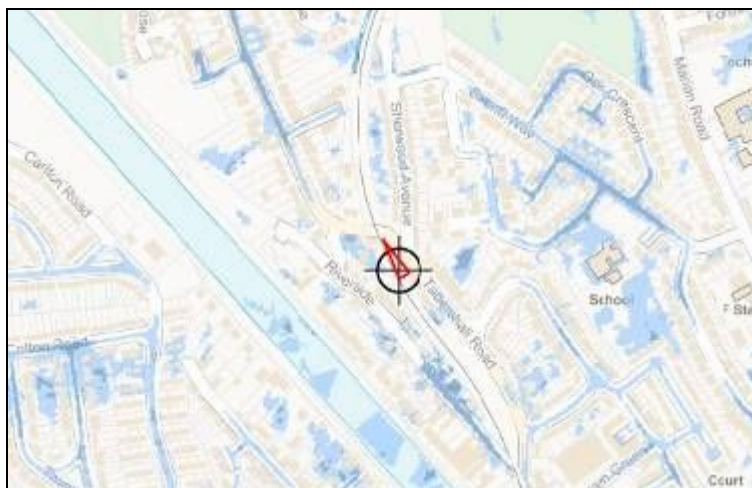
Fig 12 – surface water flood risk

There are no surface water courses that can be affected by run-off from the site and, due to the sloping surface of the site, the site is not at risk from surface water run-off flooding.
